# SERVICE BULLETIN

**TBM AIRCRAFT**

**SB 70-191**

**SUBJECT** : AILERON CONTROL CABLES

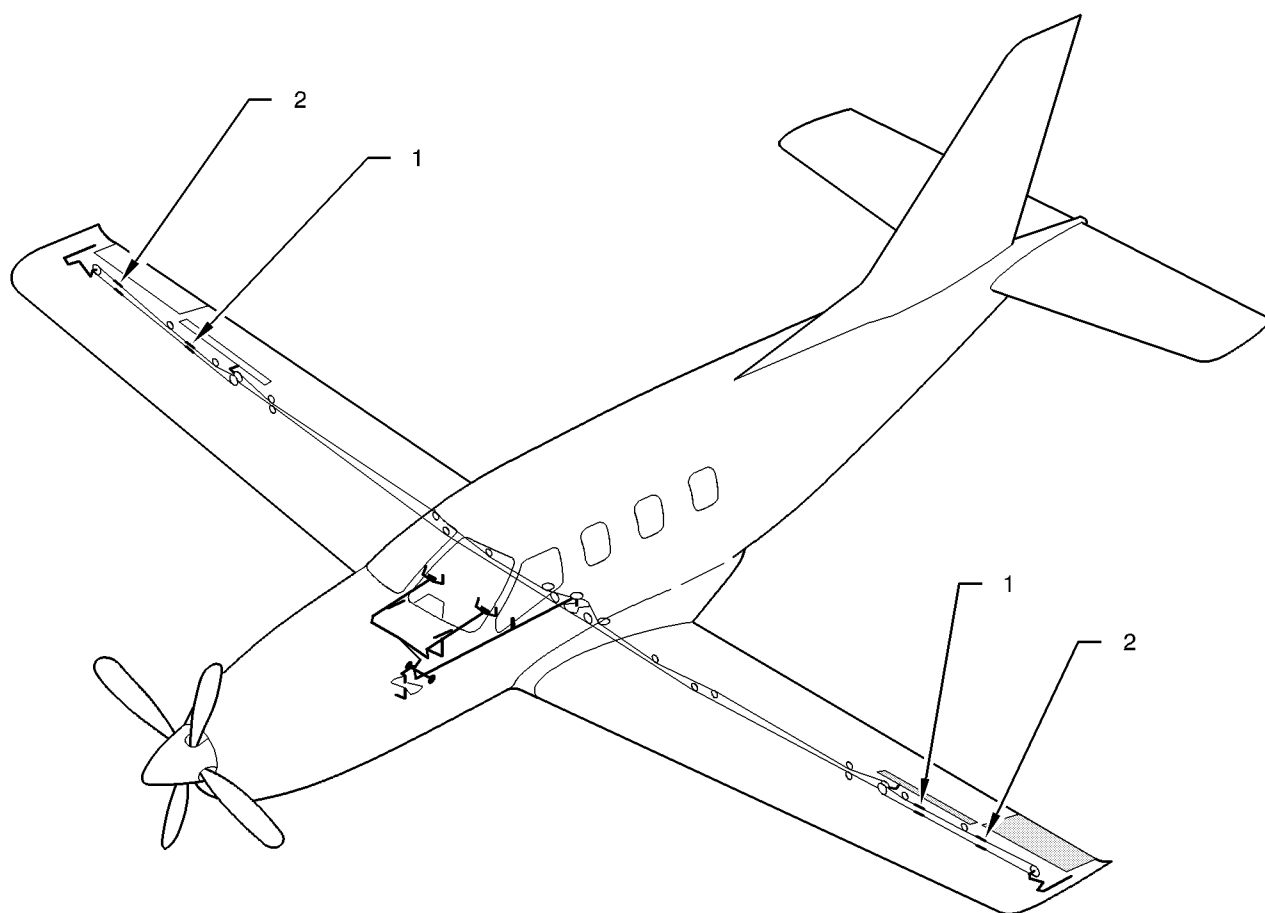
Figure 1 – Aileron control cables

Risk of aileron travel limitation resulting in lower controllability, particularly if combined with adverse flight conditions on landing and during avoidance maneuvers.

Mistake in documentation.

- 3) Lift L.H. aileron and visually check, through spoiler aperture, that cable tighteners are visible – see Figure 1.
- 4) Repeat the operation for R.H. aileron.
- 5) If cable tighteners are present at the level of spoilers, the installation is correct (1) : refer to Paragraph C.
- 6) If cable tighteners are not visible, the installation is incorrect (2) : refer to Paragraph B.

- 1 – Correct installation
- 2 – Incorrect installation

- 1) Remove R.H. and/or L.H. aileron control cables – refer to Chapter 27–10–03 of the Maintenance Manual.
- 2) Reverse the direction of cables as per the described procedure – refer to Chapter 27–10–03 of the Maintenance Manual.
