# ***FALCON SERVICE BULLETIN***

## **FALCON 2000**

**No 401-R1**

**PILOT AND COPILOT SEAT INSTALLATION  
IMPROVEMENT**

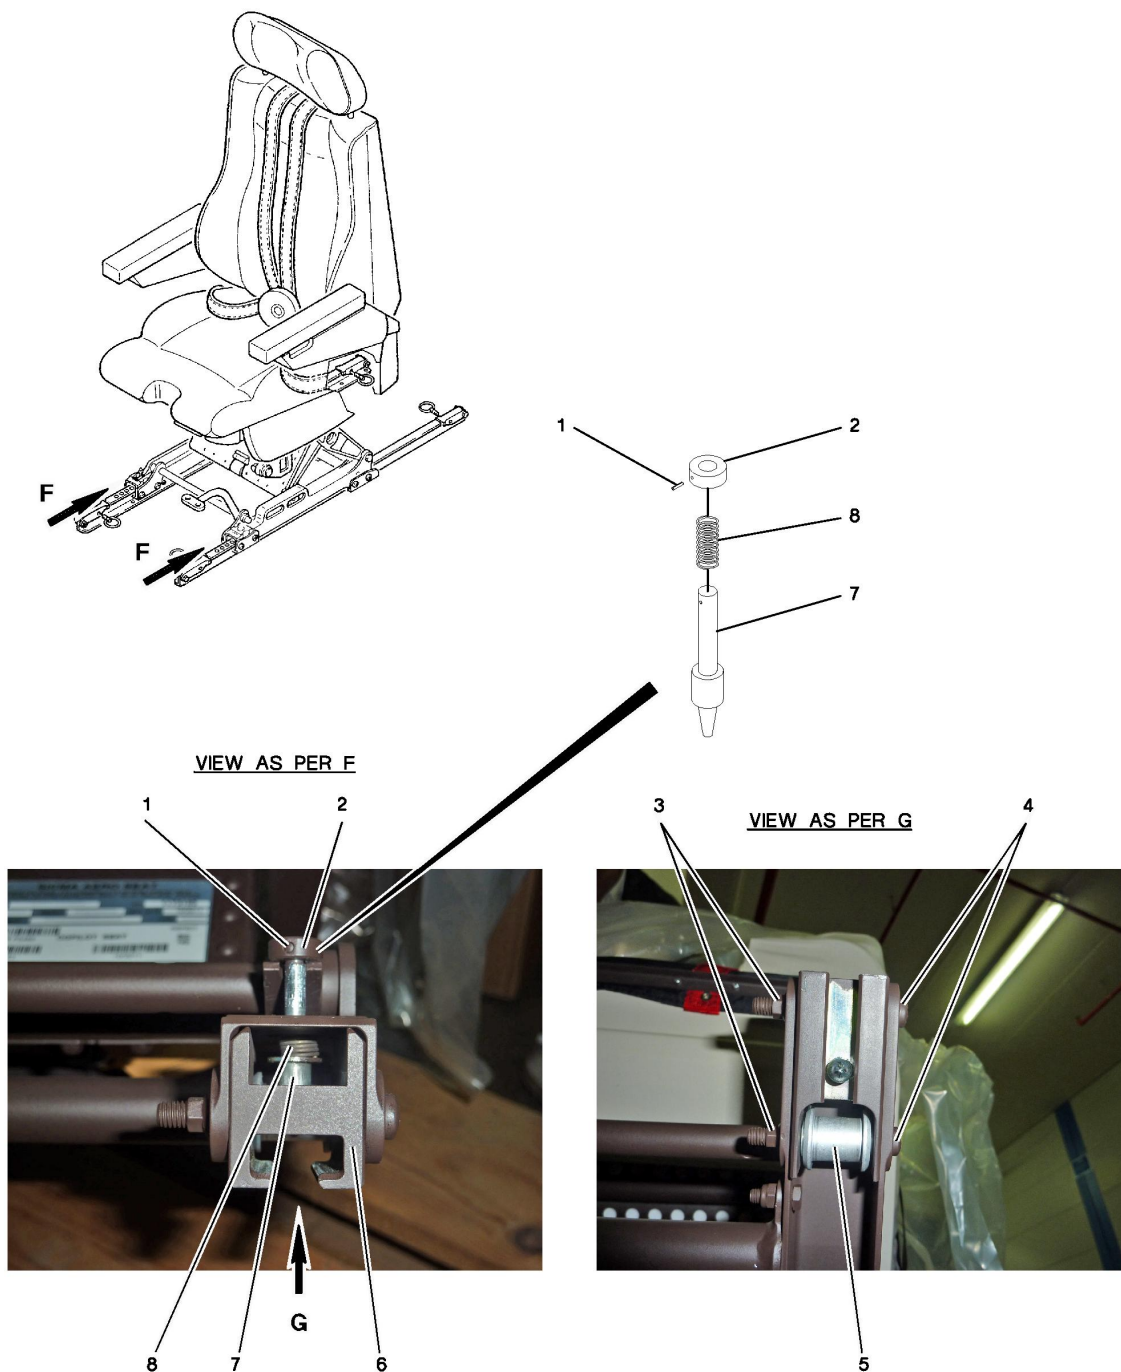
**Figure 1: LOCATION OF COMPONENTS**

A Falcon operator reported that during take-off at rotation phase, the copilot seat slid aft. Investigations showed that one locking spring fitted on a seat locking pin was broken and the other one weak.

- (1) Remove and discard the pin (1).
- (2) Remove the ring (2).
- (3) Remove the two nuts (3).
- (4) Record the position of the spacer (5).
- (5) Remove the two screws (4).
- (6) Remove the spacer (5).
- (7) Remove the front pad (6).
- (8) Remove the locking pin (7).
- (9) Remove and discard the spring (8) from the locking pin (7).

- (1) Install a new spring (8) on the locking pin (7).
- (2) Install the locking pin (7).
- (3) Install the front pad (6).
- (4) Install the spacer (5) at the position recorded on removal.
- (5) Install the two screws (4).
- (6) Install the two nuts (3).
- (7) Tighten the two nuts (3).
- (8) Install the ring (2).
- (9) Install a new pin (1).

- (8) Pull up the handle and push the pilot seat / copilot seats forward. Make sure that the two locking pins (7-fig. 1) lock the seats in all longitudinal positions when you release the handle.
