# ***FALCON SERVICE BULLETIN***

## **FALCON 2000**

**No 407-R1**

**REMOVAL OF THE TIE-DOWN SYSTEM INSTALLED FOR  
CARGO TRANSPORTATION**

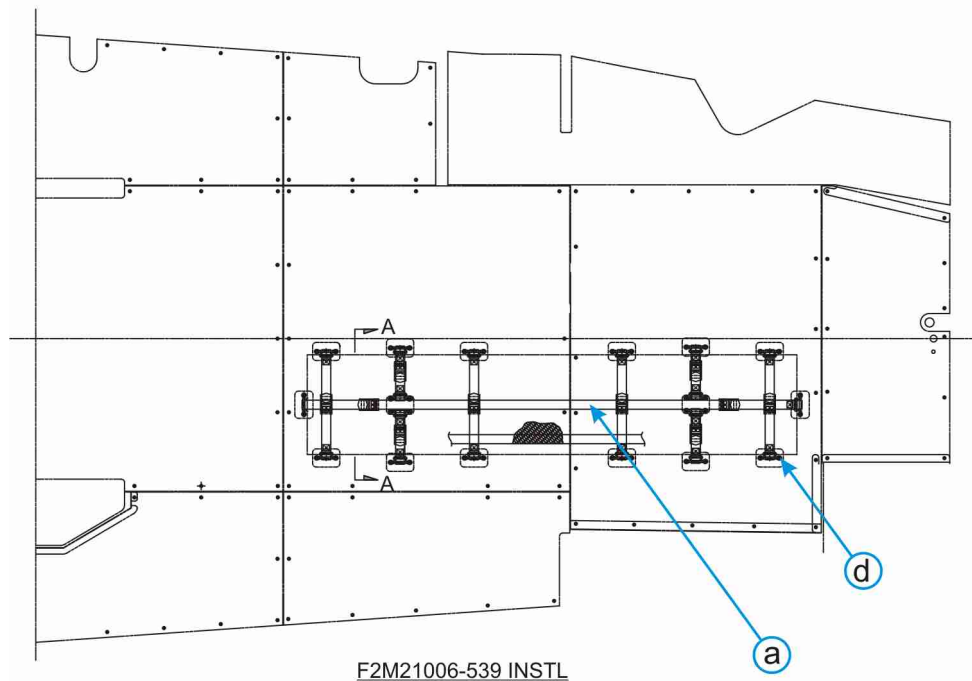
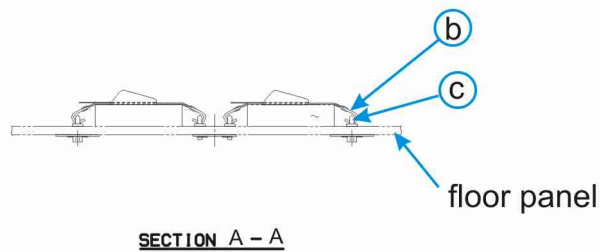
**Figure 1: TIE-DOWN SYSTEM INSTALLATION-CONFIGURATION 1**

- (a) Configuration 1 (**fig. 1**)

- 1 Release the webbing (a-fig. 1).
- 2 Remove the buckles (b-fig. 1) from the footman loops (c-fig. 1).
- 3 Remove the webbing (a-fig. 1).
- 4 Remove the screws (d-fig. 1) from the footman loops (c-fig. 1).
- 5 Remove the footman loops (c-fig. 1).
- 6 Install the new screws (P/N: NAS603-14P) and the washers (P/N: NAS1149F0332P) (d-fig. 2) in place of the old screws.
- 7 Tighten the screws.

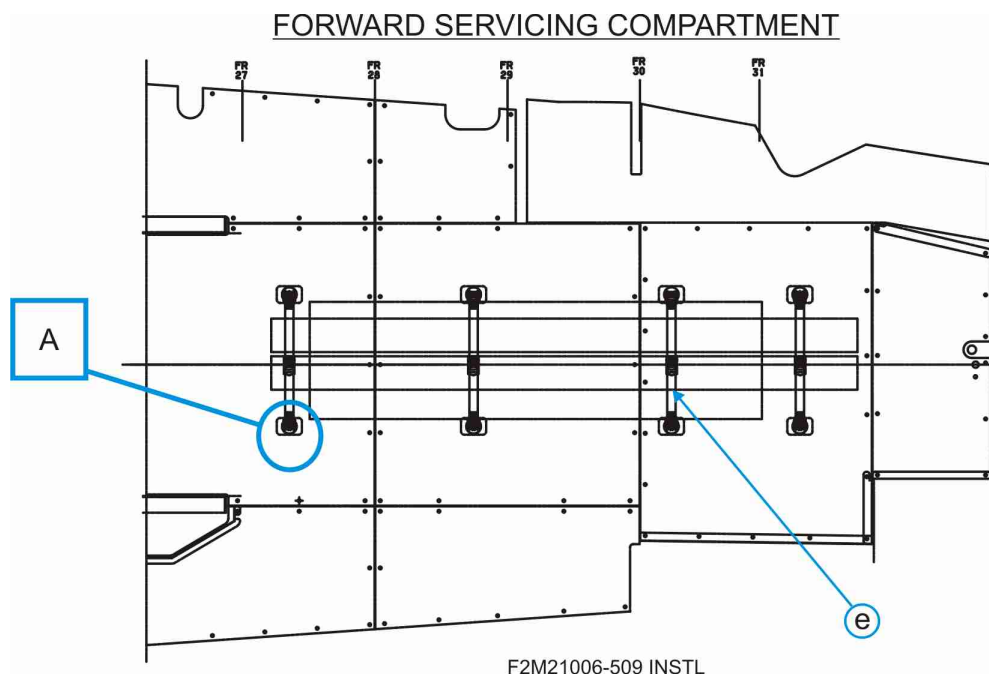
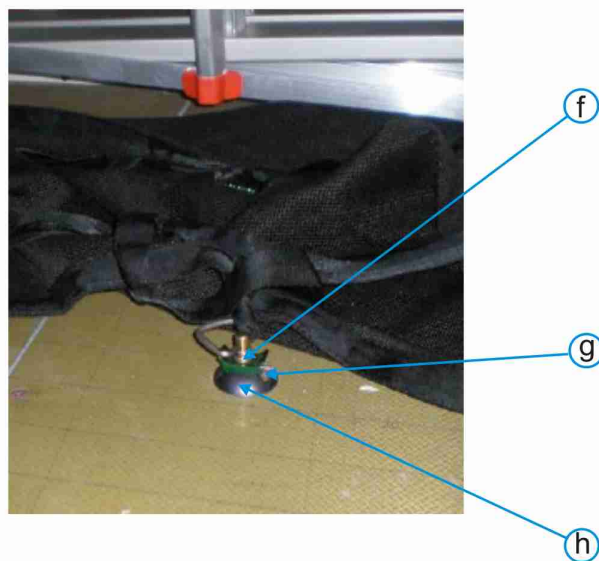
**Figure 2: TIE-DOWN SYSTEM INSTALLATION-CONFIGURATION 2**

- (b) Configuration 2 (**fig. 2**)

- 1 Release the webbing (e-fig. 2).
- 2 Remove the tie-down straps (f-fig. 2) from the tie-down fittings (h-fig. 2).
- 3 Remove the webbing (e-fig. 2).
- 4 Remove the screws (g-fig. 2) from the tie-down fittings (h-fig. 2).
- 5 Remove the tie-down fittings (h-fig. 2).
- 6 Install the new screws (P/N: NAS603-14P) and the washers (P/N: NAS1149F0332P) in place of the old screws (g-fig. 2).
- 7 Tighten the screws.

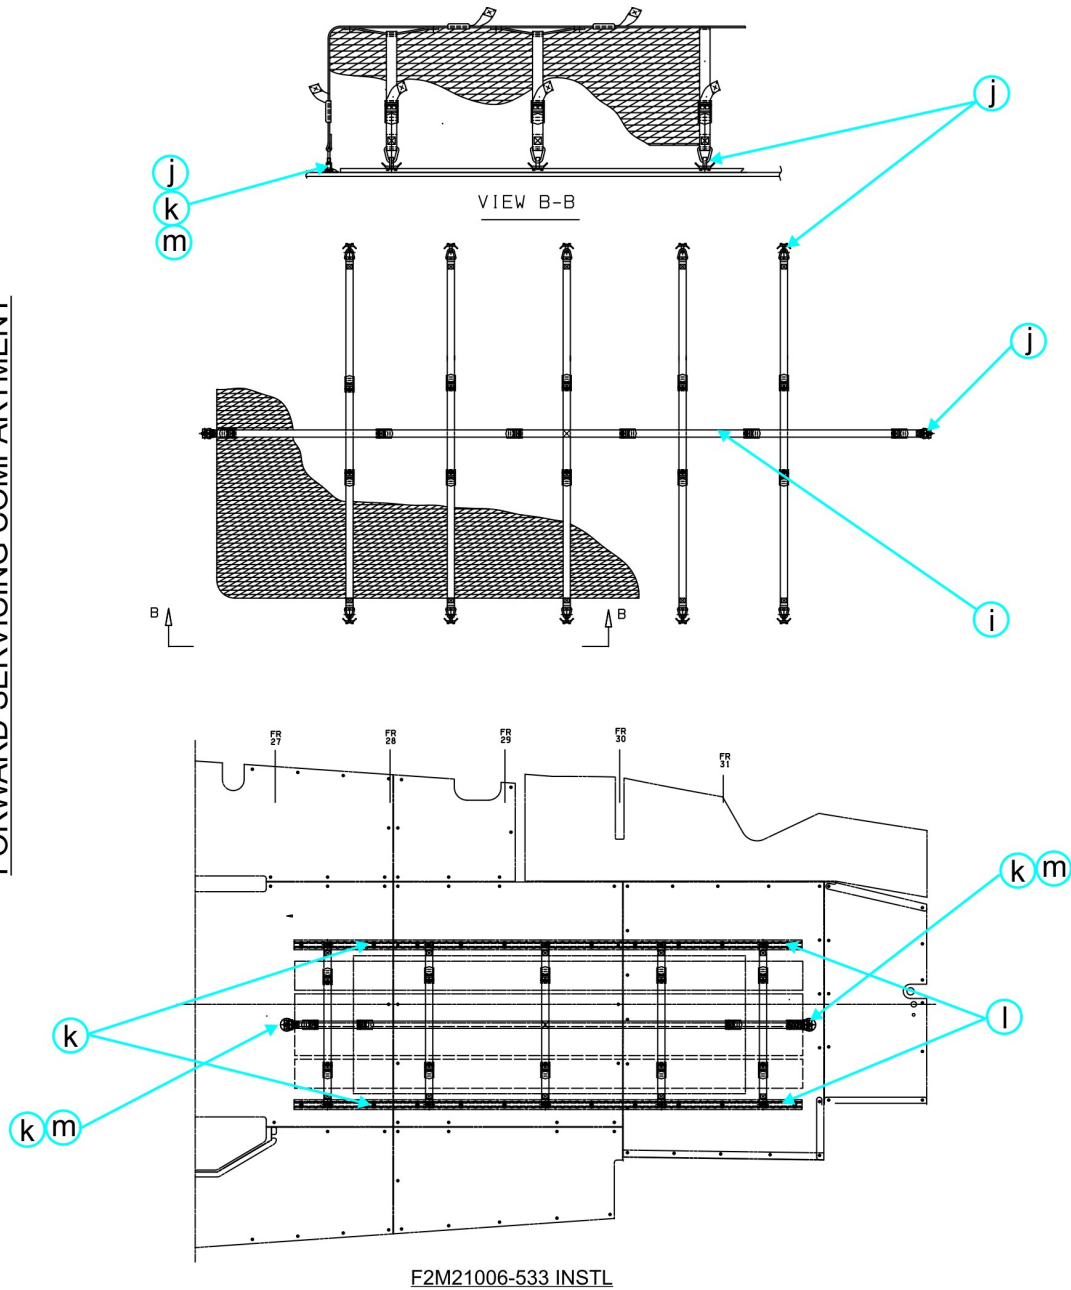
**Figure 3: TIE-DOWN SYSTEM INSTALLATION-CONFIGURATION 3**

- (c) Configuration 3 (**fig. 3**)

- 1 Release the webbing (i-fig. 3).
- 2 Remove the tie-down straps (j-fig. 3) from the tracks (l-fig. 3).
- 3 Remove the tie-down straps (j-fig. 3) from the tie-down fittings (m-fig. 3).
- 4 Remove the webbing (i-fig. 3).

- 5 Remove the screws (k-fig. 3) from the tie-down fittings (m-fig. 3).
- 6 Remove the tie-down fittings (m-fig. 3).
- 7 Remove the screws (k-fig. 3) from the tracks (l-fig. 3).
- 8 Remove the tracks (l-fig. 3).
- 9 Install the new screws (P/N: NAS603-14P) and the washers (P/N: NAS1149F0332P) to replace the fasteners of the tie-down fittings (m-fig. 3) (plate equipped with anchor nut under the floor panel).
- 10 Tighten the screws.
