# RECOMMENDED SERVICE BULLETIN

## RSB 42-139

## RSB 42NG-081

Replacement of rudder T-yoke axle with improved design.

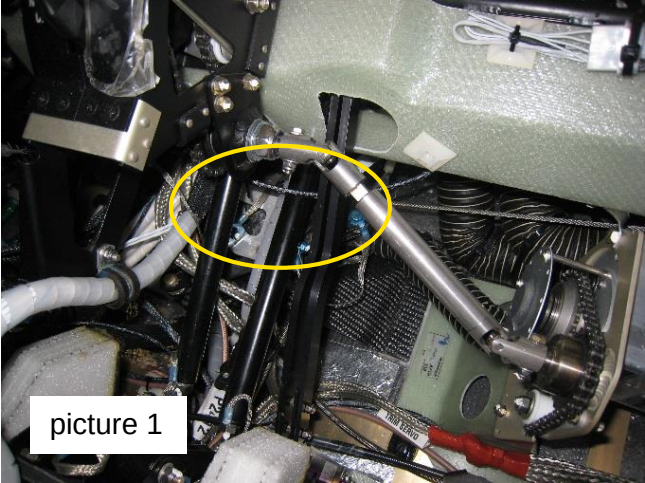
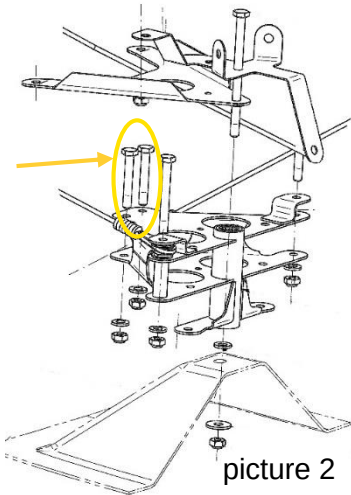
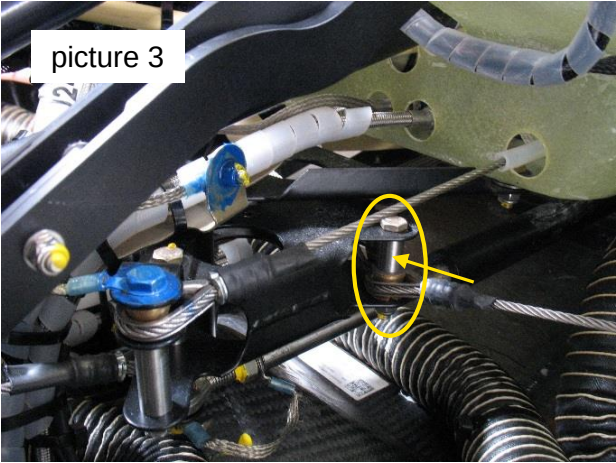
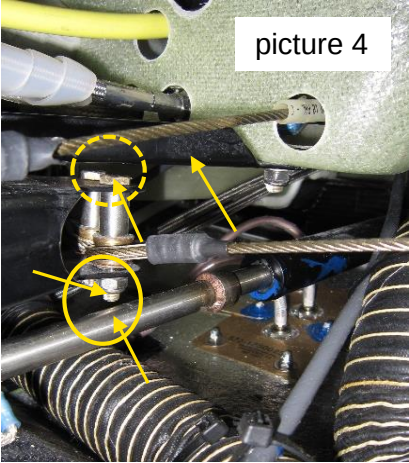
| 6. | <p>Check the clearances while moving the rudder in both directions</p> <ul style="list-style-type: none"> <li>• between end of T-yoke bolts for copilot's right rudder cable &amp; pilot's left rudder cable and nose landing gear (NLG) steering rod (continuous circle in picture 4)</li> <li>• and between head of T-yoke bolts for copilot's right rudder cable &amp; pilot's left rudder cable and support plate (dashed circle in picture 4).</li> </ul> <p>Record the measured clearances. Each clearance must be greater than 2 mm (0.08 in).</p> <p>Pictures 1 – 4 show the affected area.</p> <div style="display: flex; justify-content: space-around; align-items: flex-start;"> <div style="text-align: center;"> <p>picture 1</p> </div> <div style="text-align: center;"> <p>picture 2</p> </div> </div> <div style="display: flex; justify-content: space-around; align-items: flex-start;"> <div style="text-align: center;"> <p>picture 3</p> </div> <div style="text-align: center;"> <p>picture 4</p> </div> </div> |

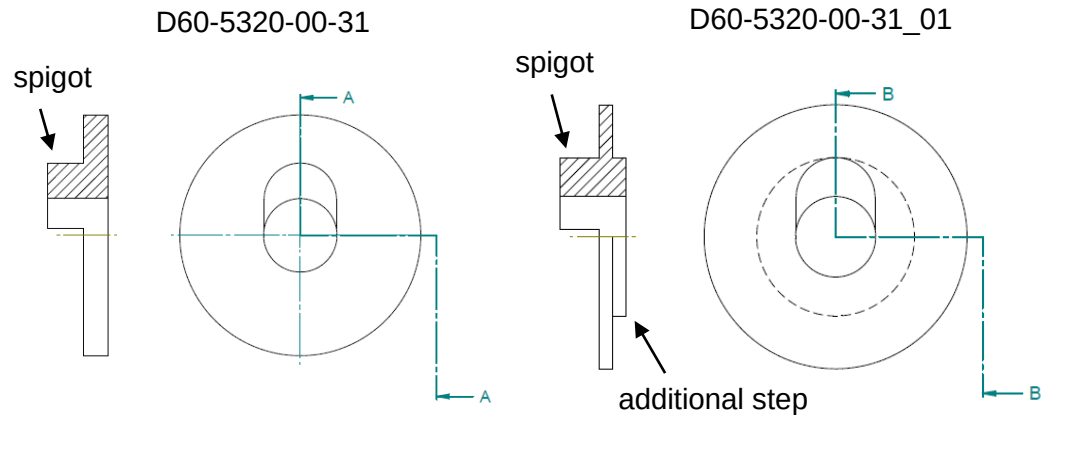
| 11. | <p>Verify, if an oblong hole washer was installed to the rudder steering bracket in accordance with MSB 42-087 / MSB 42NG-016. There are 3 different installation variants, which can be found in airplanes in field.</p> <p>Variant 1: No oblong hole washer is installed to the rudder steering bracket. Instead, a standard washer (13 mm outer diameter) is installed between T-yoke and rudder steering bracket.</p> <p>Variant 2: Oblong hole washer D60-5320-00-31 (outer diameter 20 mm) was bonded to the rudder steering bracket, in accordance with MSB 42-087 / MSB 42NG-016.</p> <p>Variant 3: Oblong hole washer D60-5320-00-31_01 (outer diameter 20 mm) was bonded to the rudder steering bracket, in accordance with MSB 42-087 / MSB 42NG-016.</p> <p>Note: The two different designs of oblong hole washers D60-5320-00-31 and D60-5320-00-31_01 can be identified in figure 1.</p> <div style="text-align: center;"> <p>figure 1</p> </div> |
