# Gulfstream G150

NUMBER 150-28A-146

FUEL (ATA 28) - INSPECTION OF LEFT AND  
RIGHT WING INBOARD VENT HOLES

JUNE 22, 2012

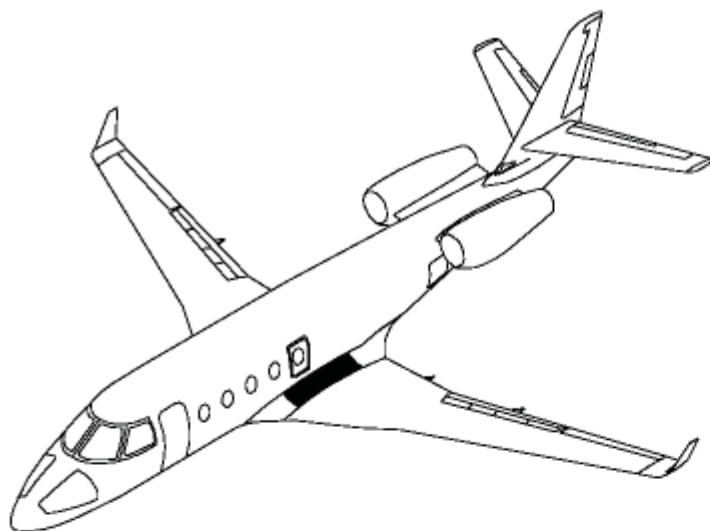
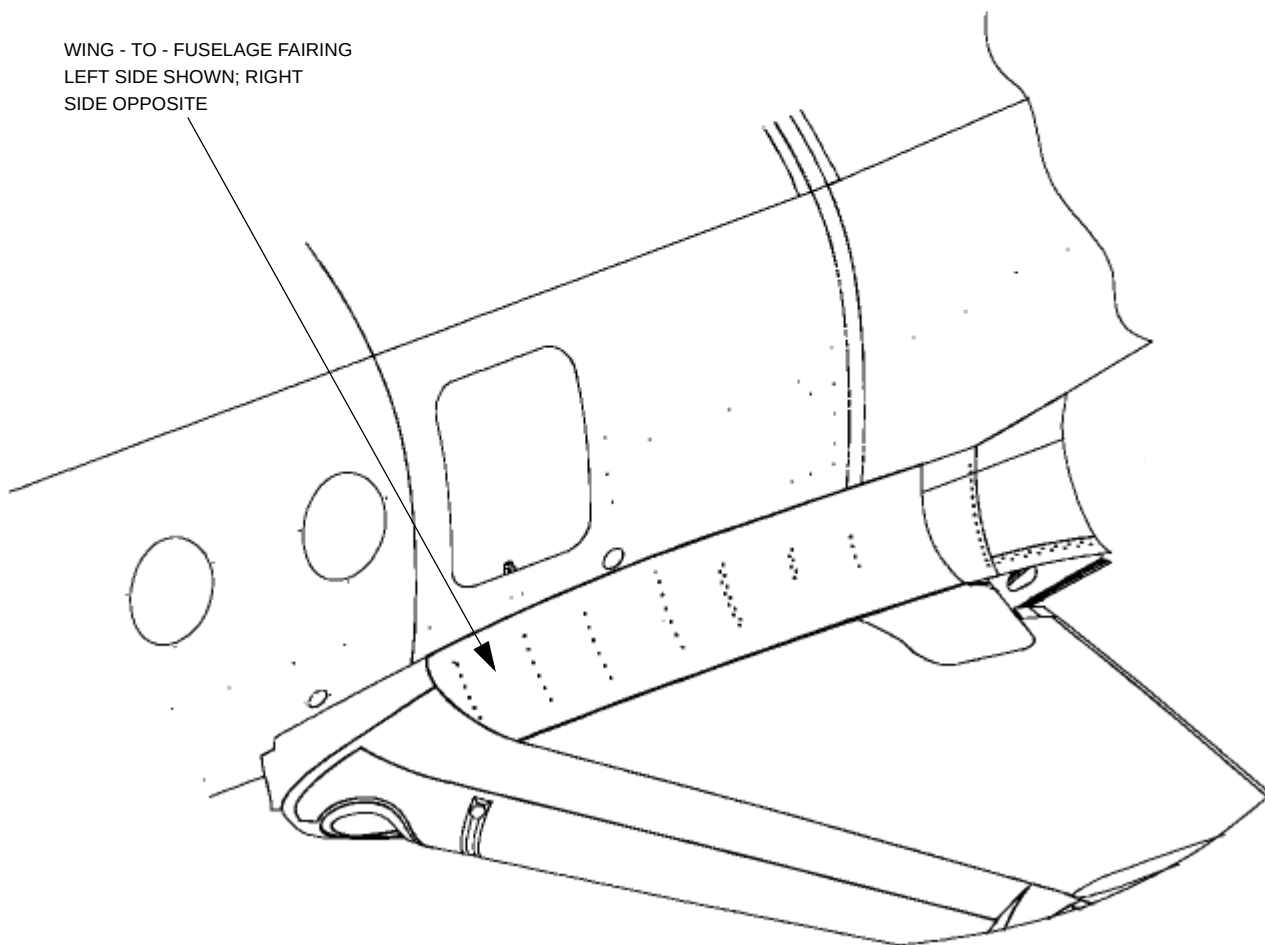
Left Wing - to - Fuselage Fairing; Right Side Opposite  
Figure 2

WING - TO - FUSELAGE FAIRING  
LEFT SIDE SHOWN; RIGHT  
SIDE OPPOSITE

- A. Remove the left and right wing - to - fuselage fairings, P/N 25G3621110-503/-504. Refer to Figure 2.
- B. Cut lockwire and disconnect B-nut fittings from union. Refer to Figure 3, Sheets 1 and 2.

7. Reinstall the left and right wing - to - fuselage fairings, P/N 25G3621110-503/-504. Refer to Figure 2 and Figure 5, Sheets 1 and 2.

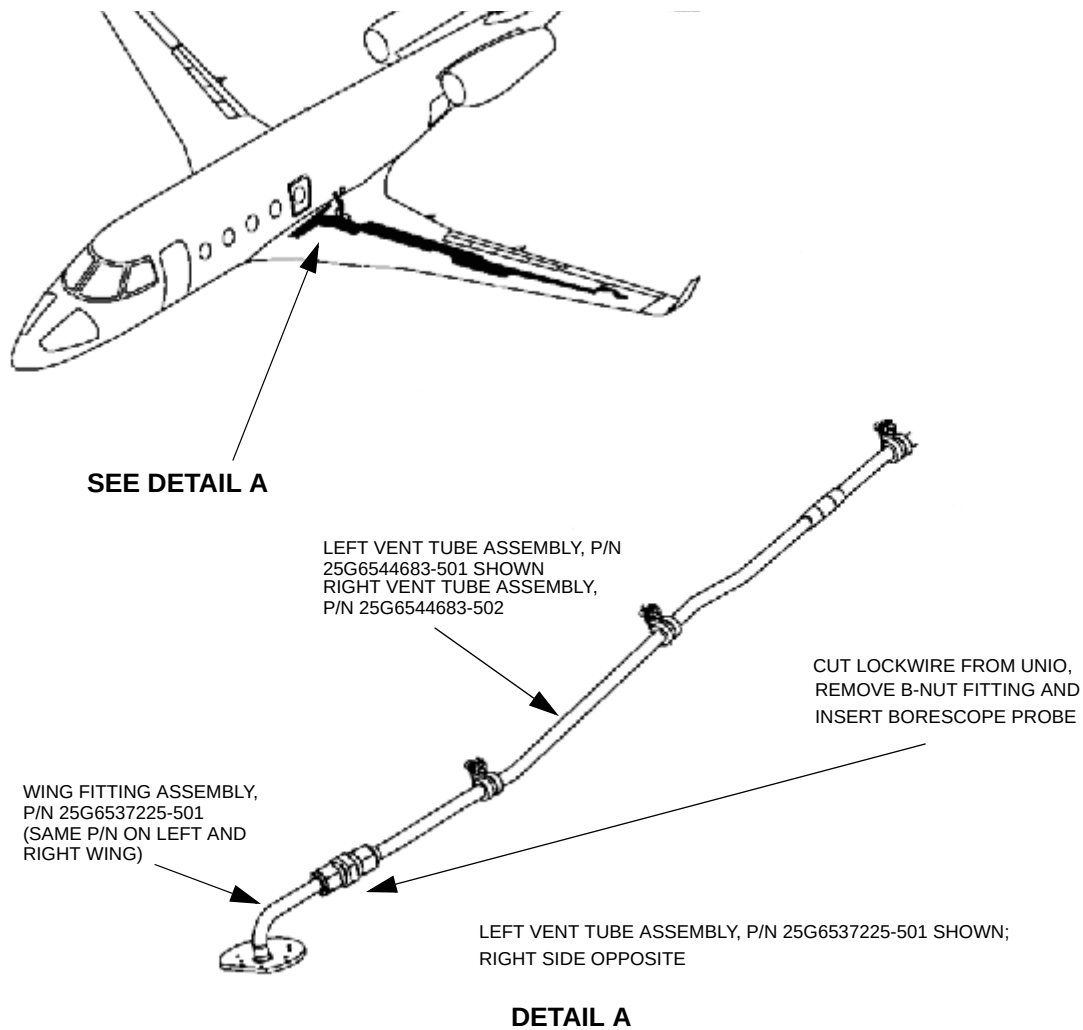
Left Wing Vent Fitting; Right Side Opposite  
Figure 3, Sheet 1

- C. Remove right wing access panel 621AB. Refer to Figure 1, Sheet 2 and AMM, Chapter 06.
  - D. Perform a detailed visual inspection (using a strong flash light and mirror) of the 3/8 inch vent holes for debris or obstruction located outboard of rib zero, internal-wing upper surface in the left and right wing. Refer to Figure 3, Sheets 1 and 2.

- E. The wing vent holes should be clear and free of any debris or obstructions. Refer to Figure 3, Sheets 1 and 2.
  - F. If no defects or other anomalies are noted and vent holes are clear and free of debris or sealant, no further action is required. Proceed to Step 4.H. below.

- G. Repeat Steps 5.A. through 5.F. for right side vent tube.
- H. Connect B-nut fittings to left and right unions. Refer to Figure 3, Sheets 1 and 2.
- I. Tighten B-nut fittings to left and right unions and secure with lockwire, P/N MS20995C.032

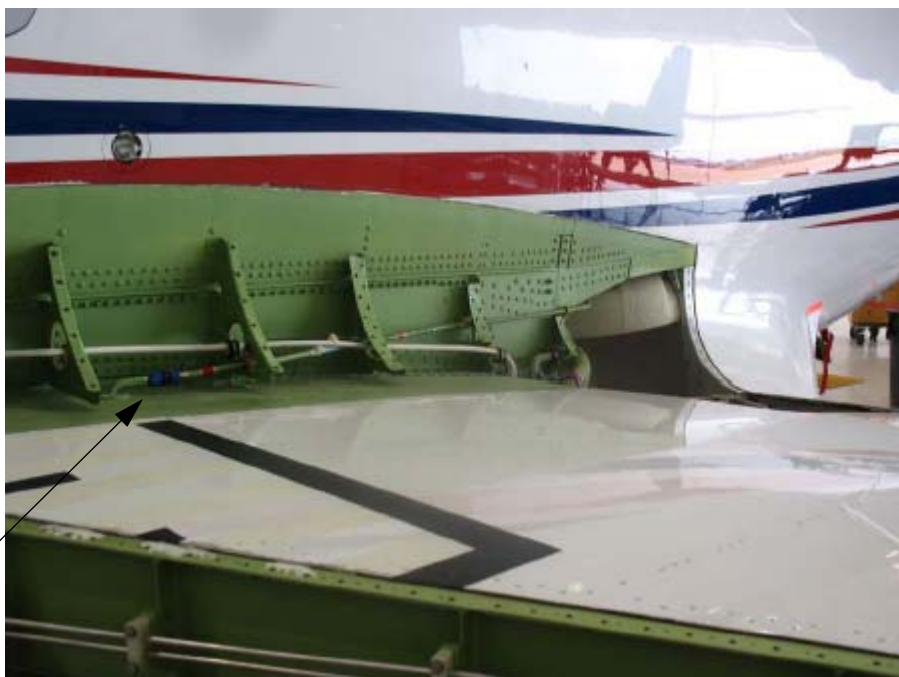
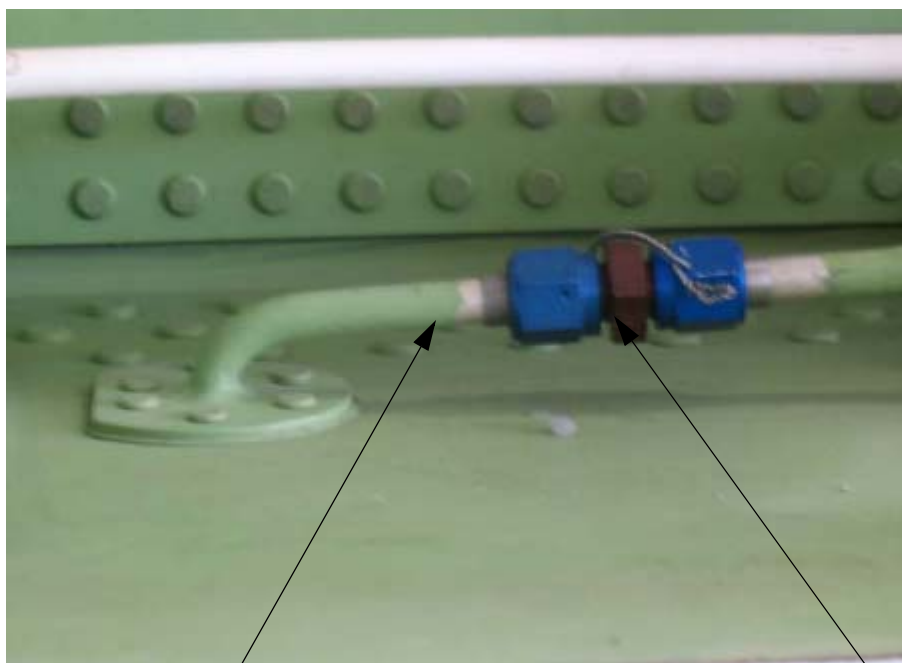
Left Wing Vent Fitting; Right Side Opposite  
Figure 3, Sheet 2

LEFT VENT TUBE ASSEMBLY, P/N 25G6537225-501 SHOWN,  
RIGHT SIDE OPPOSITE

CUT LOCKWIRE FROM UNION,  
REMOVE B-NUT FITTING AND  
INSERT BORESCOPE PROBE  
HERE

- C. Remove as necessary clamps, screws and washers securing wing vent relief tube to the support structure.
- D. Using a borescope, inspect vent hole by inserting boroscope through fitting tube assembly, P/N 25G6537225-501. Inspect for debris/sealant blockage at wing vent orifice.

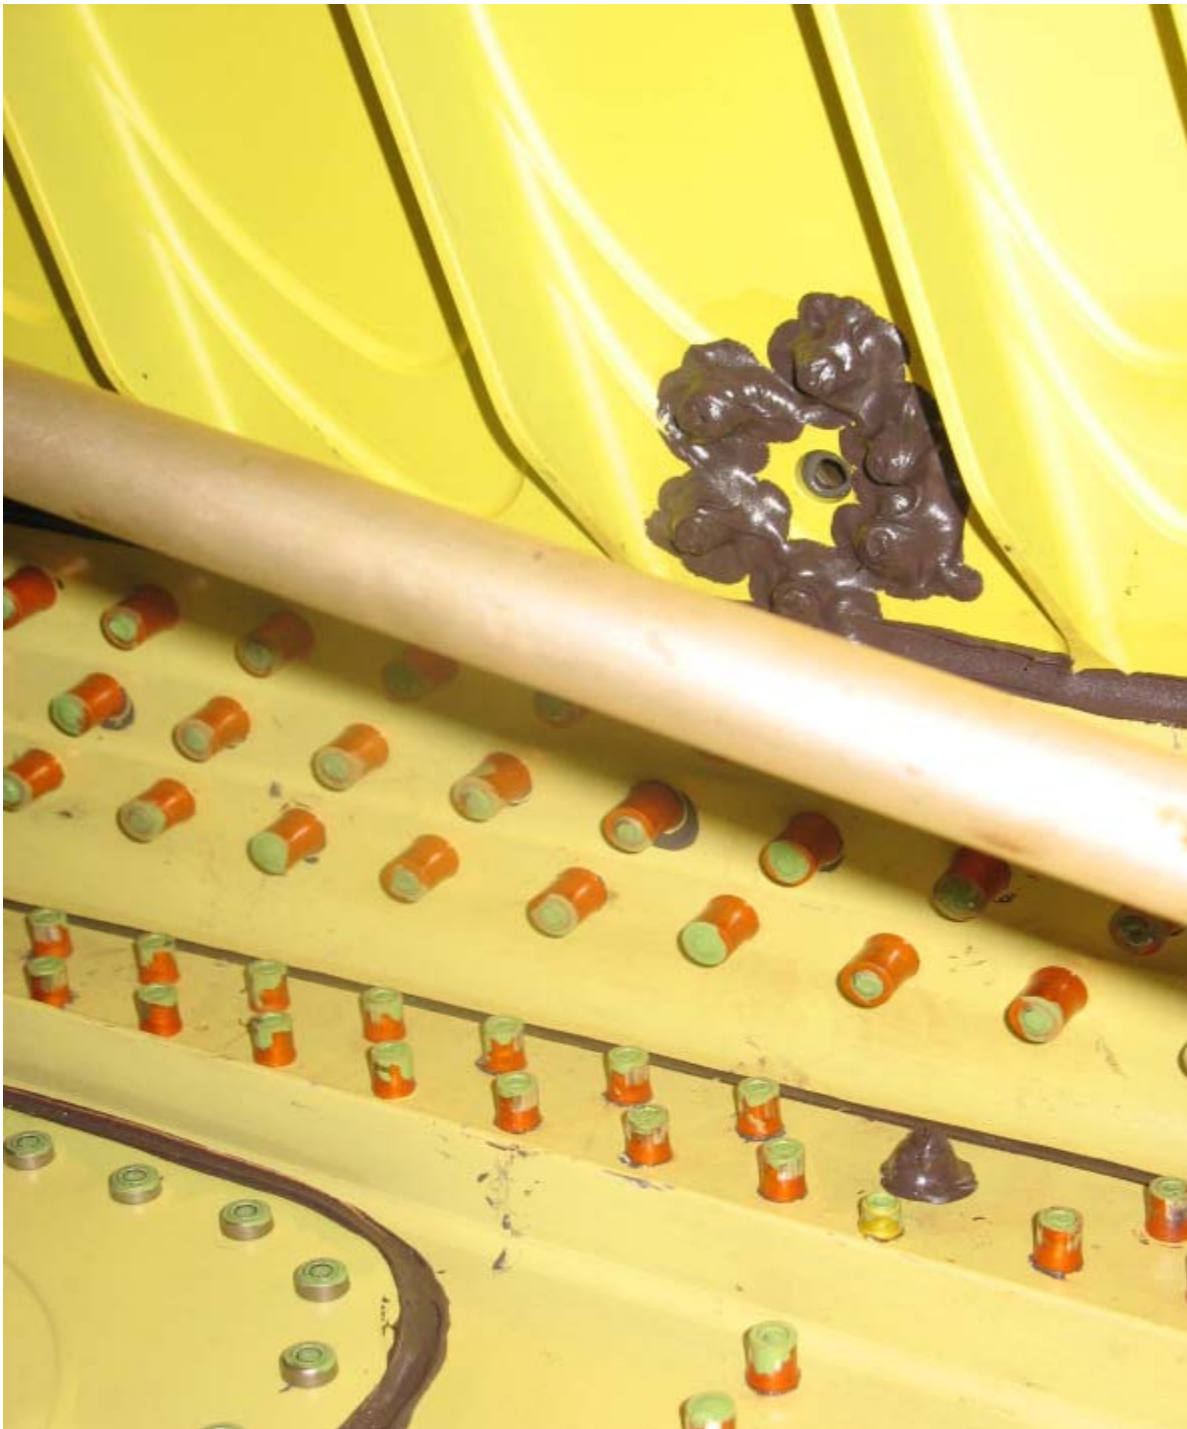
RIGHT SIDE SHOWN; LEFT SIDE OPPOSITE

Example of Vent Shown with no Sealant (Correct)  
Figure 4, Sheet 1

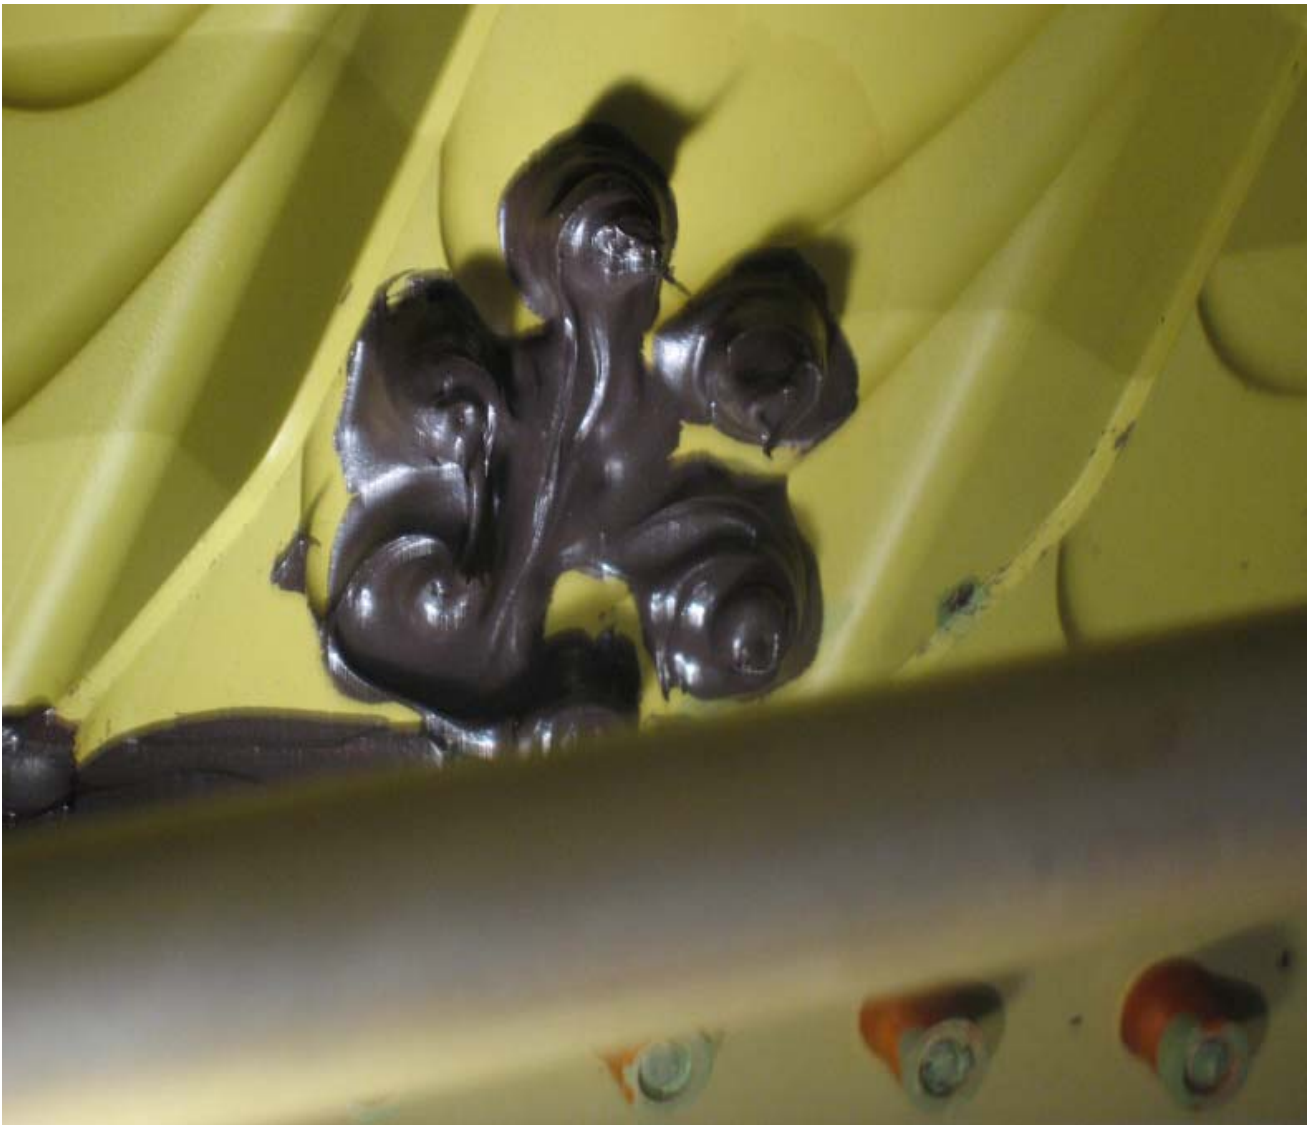
Recent inspection of a G150 aircraft following flight revealed several fasteners protruding from the lower wing surface. Initial investigation of the wing interior revealed several structural rib assemblies damaged and separated from the wing plank. Further investigation has revealed the wing vent tube covered with sealant, essentially blocking the path for air to exit the wing during fueling operations and thermal expansion. Continued operation in this condition has the potential to compromise the integrity of the wing structure. The potential exists for this condition to be present on other aircraft.

Example of Vent Shown Covered with Sealant (Incorrect)  
Figure 4, Sheet 2

- G. If any defects or any other anomalies are present, or vent openings are covered/sealed, contact Gulfstream Customer Support at 800-810-4853 or 912-965-4178 for further instructions.
- H. Reinstall left wing access panels 521AB. Refer to Figure 1, Sheet 1 and AMM, Chapter 06.
- I. Reinstall right wing access panel 621AB. Refer to Figure 1, Sheet 2 and AMM, Chapter 06.
- J. If aircraft was defueled for inspection, refuel aircraft. Refer to AMM, Chapter 12.
