# Gulfstream G150

NUMBER 150-52-188

DOORS (ATA 52) – MAIN ENTRANCE DOOR  
(MED) – AIRSTAIR – INTERNAL MICROSWITCH  
ADJUSTMENT

JANUARY 15, 2016

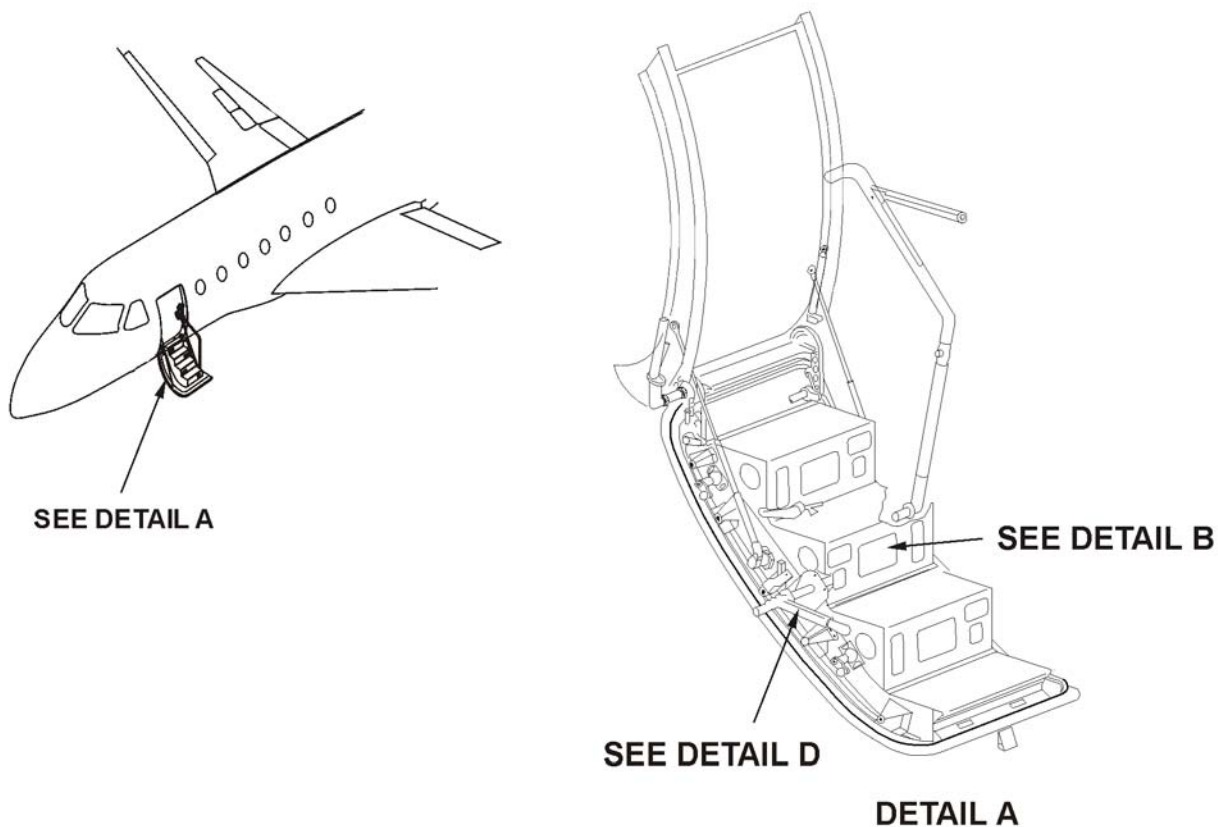
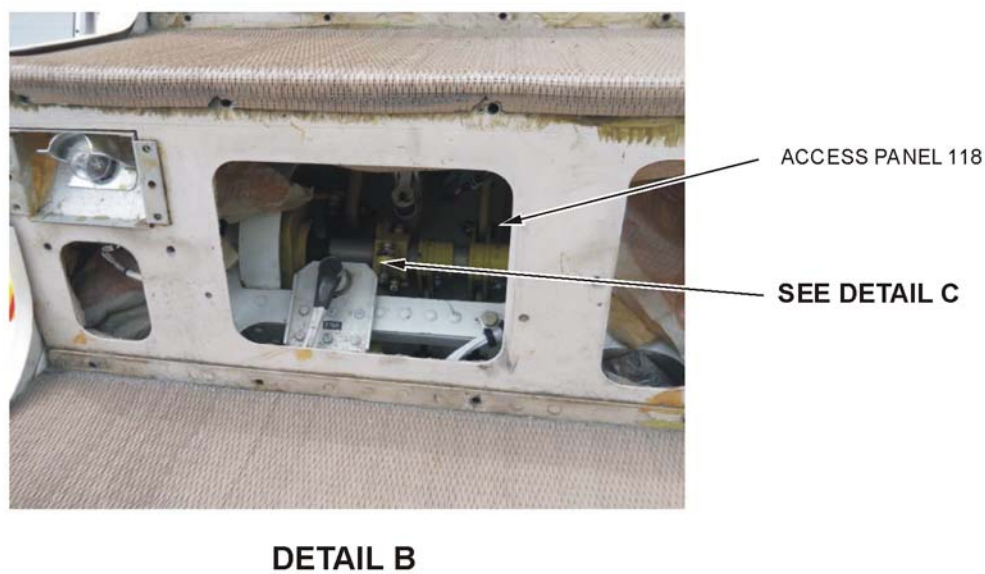
Airstair Door Internal Microswitch - Adjustment  
Figure 1 (Sheet 1)

Subsequent to a recent event in which the Main Entrance Door (MED) of an Astra aircraft opened during flight, a detailed review of the door rigging and operation determined that, in certain instances, the CABIN DOOR UNLOCK Crew Alerting System (CAS) message may extinguish before the handle latch pin is fully engaged. We have identified an improved switch adjustment that will extinguish the warning light only after the handle latch pin is fully engaged.

1. Prepare aircraft for safe maintenance. Refer to AMM, Safe Ground Maintenance Procedure, Chapter 20.
2. Connect electrical power to aircraft. Refer to AMM, Chapter 20.
3. Perform door airstair inner microswitch, 276H, (3) updated rigging adjustment procedure, as follows (refer to Figure 1):
  - A. Open door and remove access panel 118 from door to access the inner door microswitch (3). Refer to Figure 1, Sheet 1 and 2.
  - B. Pull, tag and install safety clip on Circuit Breaker (CB) 6L on left DC power box in equipment compartment. Refer to AMM, Chapter 24.
  - C. Remove safety wire from jam nut (2). Refer to Figure 1, Sheet 2.
  - D. Hold microswitch (3) securely and remove jam nut (2) at bracket (4). Refer to Figure 1, Sheet 2.

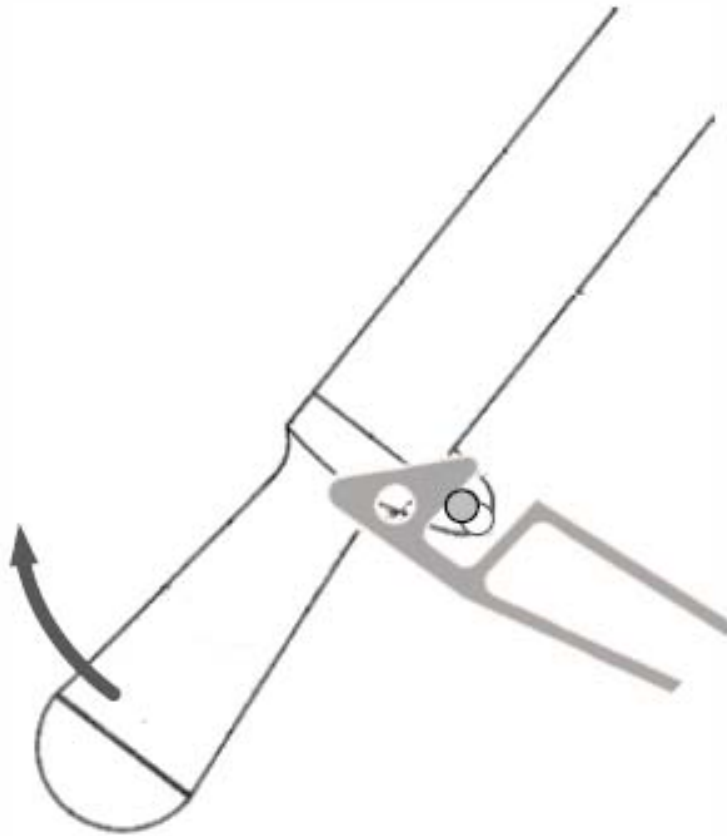
Airstair Door Internal Microswitch - Adjustment  
Figure 1 (Sheet 3)

SECTION OF THE STIRRUP AND PIN CONTACTING  
THE CHANNEL FACE WHEN HANDLE IS ROTATED  
TOWARDS THE UNLOCKING POSITION

- G. Depress lever on aft side of door and rotate the handle towards the unlocked position until it contacts the stirrup. Ensure the CABIN DOOR UNLOCK CAS message is not displayed. Refer to Figure 1, Sheet 3.

- (1) If CABIN DOOR UNLOCK message displays, add back the washer (1), P/N NAS1149G0816P that was removed in Step 3.H. above.
- J. Depress lever on aft side of door and rotate the handle towards the unlocked position until it contacts the stirrup. Ensure the CABIN DOOR UNLOCK CAS message is not displayed. Refer to Figure 1, Sheet 3.
