American Bonanza Society Air Safety Foundation

# **Flight Controls, Flaps and Trim System Inspection, Repair and Rigging Guide**

For Beechcraft Bonanza, Debonair, Baron and Travel Air

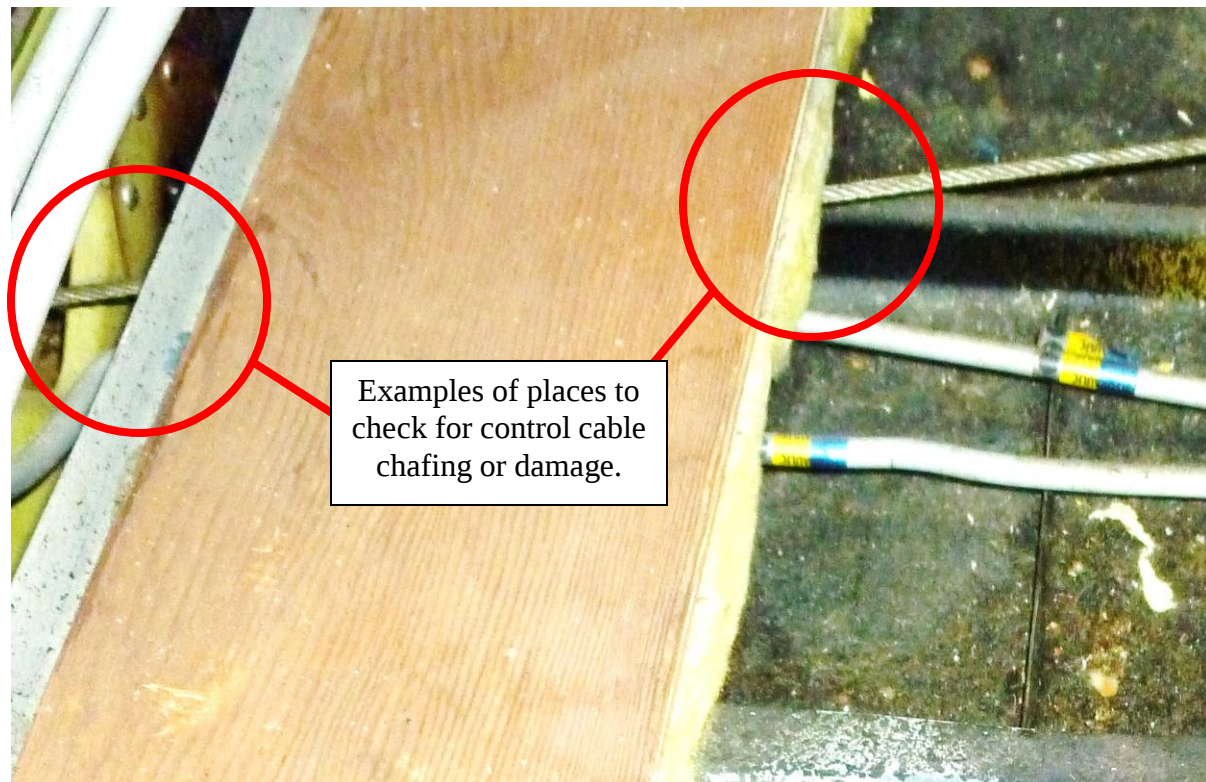
Examples of places to check for control cable chafing or damage.

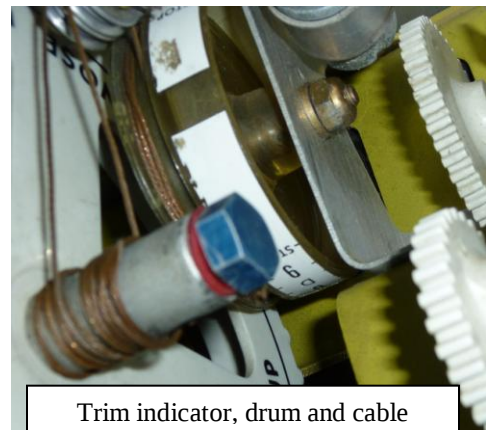
Trim indicator, drum and cable

**Discrepancy: The elevator trim indicator drum cable is frayed or broken.**

1. Set the elevator trim tabs to neutral.
2. Remove the trim indicator and cable.
3. Check that the indicator drum and indicator cable idler pulleys rotate freely on their shafts.
4. Apply a drop of lube on the shafts.
5. Install elevator trim indicator cables per instruction in the Beechcraft Shop and Maintenance Manual.
6. Set tension on the idler so the cable works correctly on the trim wheel.

**Caution:** The first sentence of the Beech Shop manual instruction on section 3 page 61 paragraph b. is incorrect. *You need to wrap cables a full turn in opposite directions.* The rest of the instructions are correct.

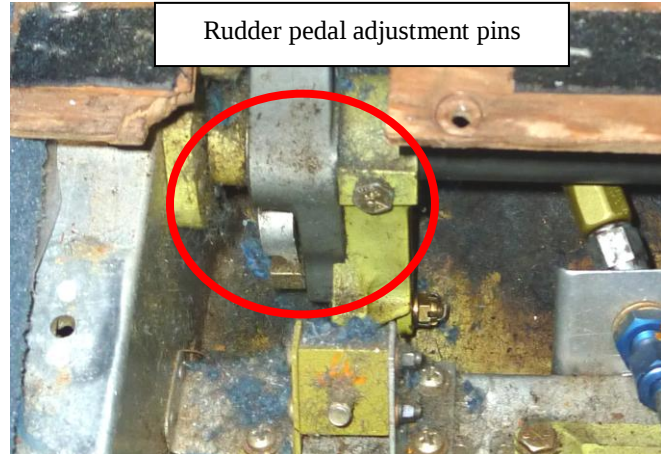
Rudder pedal adjustment pins

**Discrepancy: The rudder pedal adjustment pins are frozen.**

**Tip:** Frozen rudder adjustment pins are usually the result of corrosion.

1. Apply penetrant oil on the latch pin. Allow it to seep in to free up the pin.
2. If penetrant oil does not work, remove the latch pin lever. It is held on with a screw on the forward side of the pedal arm.
3. Gently rotate the latch pin with an open end wrench until it is free.
4. Clean and treat any corrosion.
5. Lubricate the pin and reassemble the latch.
6. Check for proper pin engagement.

**Tip:** Remove corrosion with a small round wire brush, or 220 wet/dry sandpaper taped around a small wooden dowel. Use a cotton swap to apply Alodine and Magnadyne, then (after completely drying) zinc chromate.

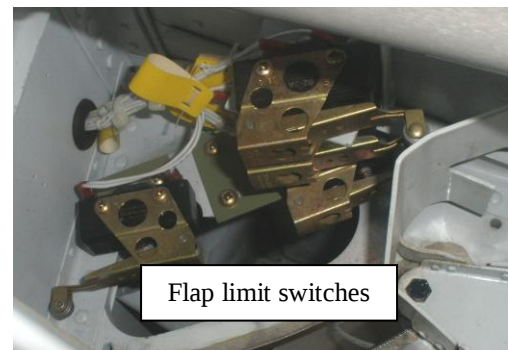
Flap limit switches

1. The flap motor limit switch is not turning off the motor prior to one or both flaps reaching the end of a flap track.

4. If the right flap is hitting end of track slot, adjust the length of the right flap actuator jack screw.
  - a. Extend the flap fully down to gain access to the flap actuator attach bolt at the flap bracket.
  - b. Inspect the area at the leading edge of the flap actuator flap bracket for cracking.
  - c. Remove the flap actuator attach bolt from bracket.
  - d. Turn the jack screw in or out ½ turn and reinstall the attach bolt (tighten bolt tight against flap actuator bushing).
  - e. Check travel with rope chalk or play dough.
  - f. Repeat steps d and e until correct travel is achieved.

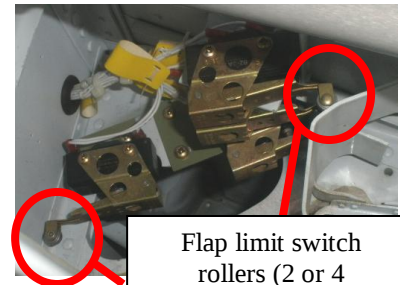
Flap limit switch rollers (2 or 4 depending on model)

**Tip:** Flap hunting normally happens in flight with an air load, but is sometimes seen when selecting the approach position on the ground. Periodically check rollers for freedom to roll, and frequently lubricate the rollers with LPS 1 to prevent bending the switch arms.

1. Check that the switch activator arms for the 11/14- and 12/16- degree position switches (the center two switches banked together) are not bent.
2. Straighten switch actuator or adjust switches for a 2 degree separation of flap travel as necessary.
3. Check that the rollers on the end of the switch arms are free to roll.
4. Lubricate the switches rollers with LPS 1.

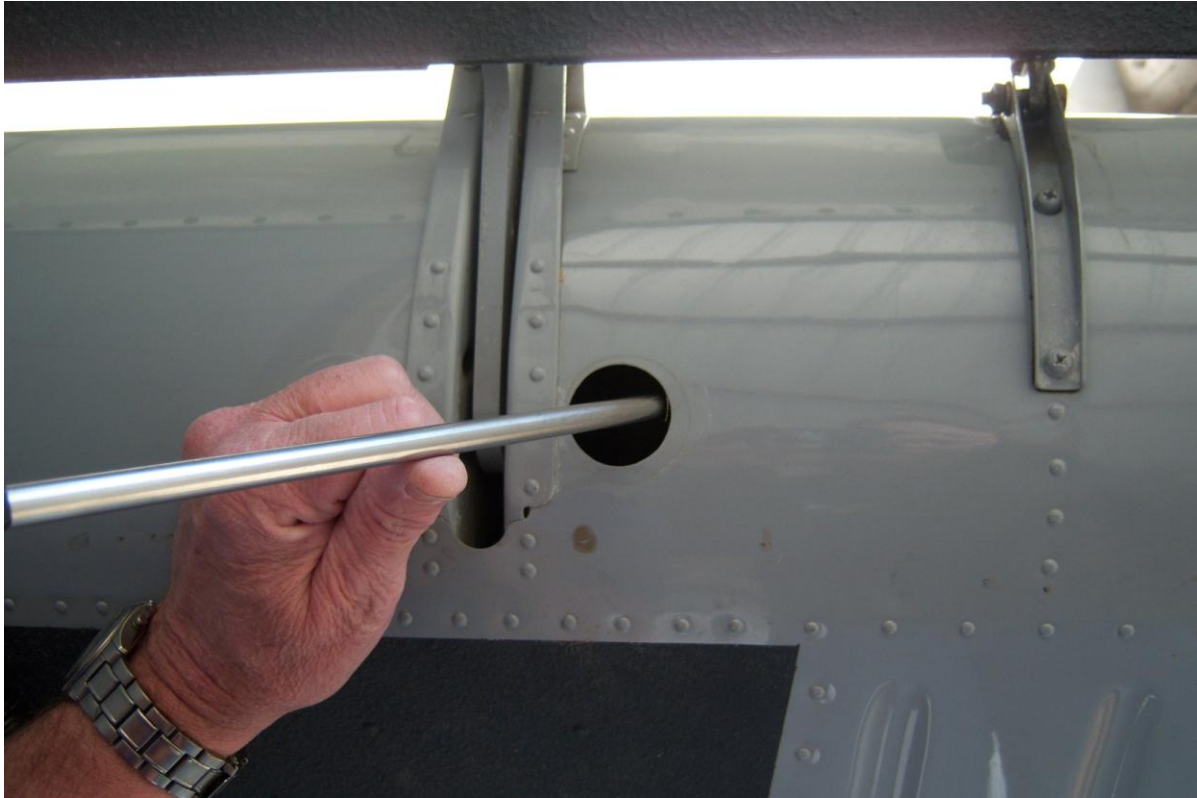
**Discrepancy: There is crack damage to the nose rib assembly for the flap actuator attachment bracket.**

AREA OF POTENTIAL CRACKS

EXAMPLE OF CRACK IN P/N 35-165050-84 NOSE RIB

EXAMPLE OF TORN FLANGE IN P/N 35-165050-84 WITH NUTPLATE MISSING

Address cracks in accordance with Hawker Beechcraft Safety Communiqué 313 rev. 1.

**Tip:** The leading rib can be inspected with a borescope by removing the Tinnerman plug at the inboard flap track. The leading edge rib will crack before the flap skin.

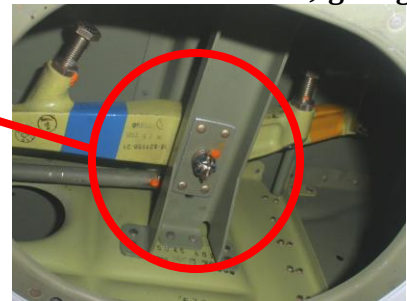
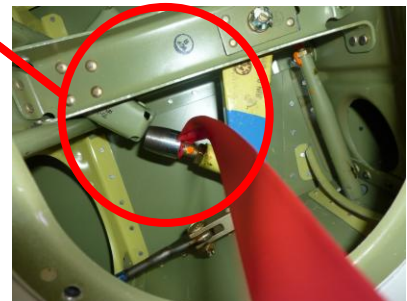
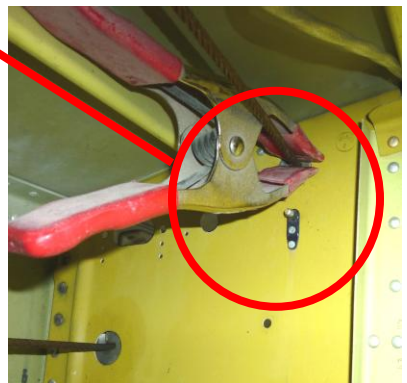
**Discrepancy: The aileron forward push-pull rod end is worn at the bell crank, giving excessive vertical movement on aileron trailing edge.**

1. The bell crank pivot bolt needs to be removed to gain access to the forward push-pull rod end.
2. Remove the forward cable to release the preload on the bell crank pivot bolt.
  - a. To make this process simpler, install a short, 1/2" socket on the opposite aileron's aft stop bolt. Attach a warning flag to the socket.
  - b. Remove the cotter pin and nut from the forward cable clevis of the bell crank being removed.

**Tip:** Clipping a hand spring clamp on the balance cable at the fairlead (inside the wing inboard bottom inspection panel next to the outboard gear door) will help prevent the cable from sagging through the fuselage and opposite wing. Attach a warning flag.

- c. Apply up pressure on the aileron trailing edge at the inboard end rib, to stretch the aileron cable slightly and release pressure on the balance cable.
  - d. Remove the clevis bolt.
3. Remove the aileron and aft rod end attach bolt as described on page 18.
4. Remove the Tinnerman plug on the top wing skin.
5. Remove the pivot bolt. Tap the bolt out with a 3/16" pin punch.
6. Move the bell crank to gain access to the rod end.

7. Remove the attach bolt.
8. Measure the distance along the centerline of the rod end from the ball to the end of the push-pull tube.
9. Remove the old rod end, and attach the new rod end to the same length as the one removed.
10. Reinstall the push-pull rod, attach bolt and cotter pin.
11. Reinstall the bell crank.
12. Tighten the pivot bolt securely and attach a cotter pin.
13. Reattach the push-pull rod attach bolt to the inboard aileron hinge bracket.
14. Tighten the forward push-pull rod end jamb nut.
15. Check that the push-pull rod rotates freely edge to edge.
16. Reinstall the aileron.
17. Apply up pressure on the aileron to stretch the aileron cable.
18. Install the clevis bolt, install the nut, and safety with a cotter pin.
19. Remove the ½ inch socket and warning flag from the aileron bell crank stop.
20. Remove the hand clamp and warning flag.

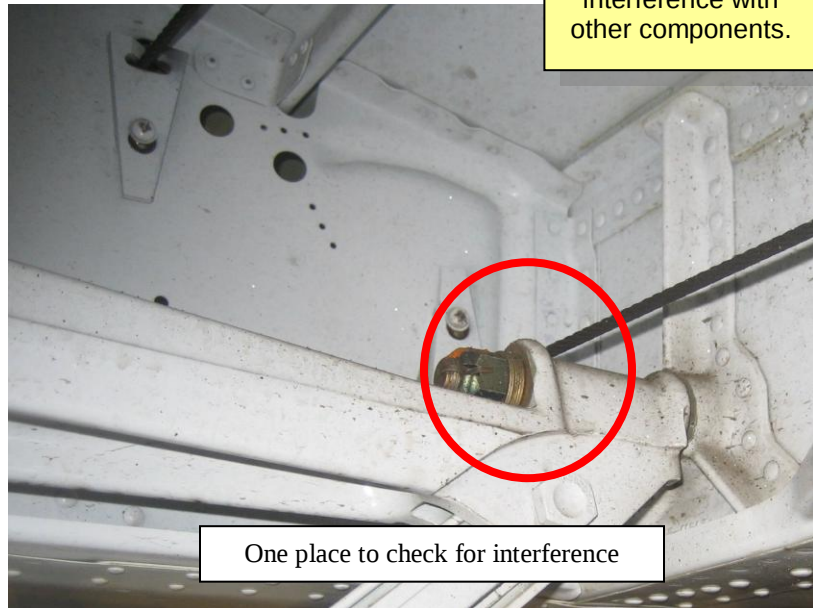
One place to check for interference

**Tip:** Fairleads are used to redirect a cable slightly for alignment, and to prevent wear interference with other components.

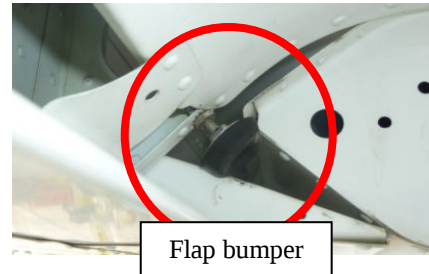
**Discrepancy: A flap bumper is loose or a bumper nut plate is broken.**

1. Remove the aileron for easier access.
2. Loosen the bumper from the broken nut plate.
3. Remove the bumper and mounting screw.
4. Drill out the solid rivets.

**Tip:** Because of restricted access, bucking a solid rivet is very difficult. We suggest installing a washer with a lock washer under the flap bumper jamb nut.

5. Install a new nut plate using countersunk nut plate P/N CCR244SS-3-02 blind rivets.
6. Adjust the flap bumper to supply a light preload on the flap.
7. Reinstall the aileron and check operation.

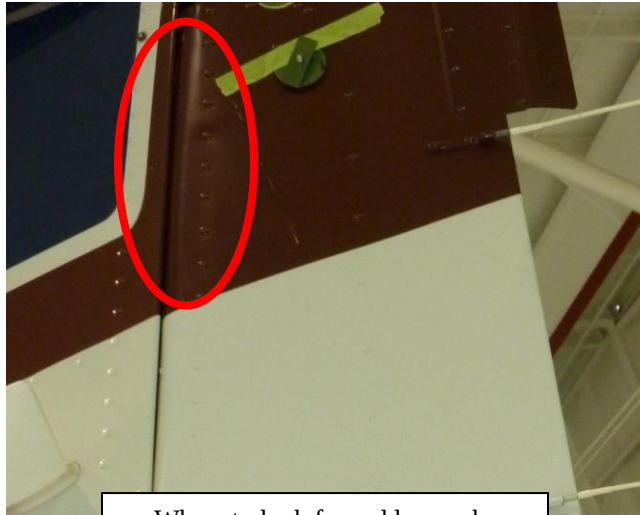
Where to look for rudder cracks

**Tip:** Check for cracks developing on the skin from any rivet location with a preload on the skin. If caught early, a small stop drill hole 1/8 inch from the end of the crack can arrest the crack progression. Cracks normally run parallel with the rivet line along the spar. Often a small crack is undetected and travels quickly with oil canning of the skin.

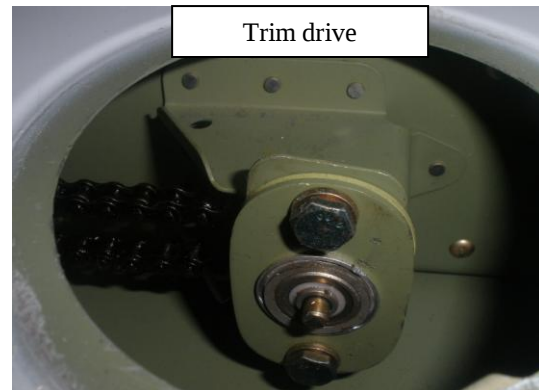
Trim drive

**Tip:** Often a step will wear in the brass Acme thread nut in the actuator. Grease may be dirty, old, and caked.

3. Check the trim actuator for freedom of movement.
4. Disconnect the drive chain from the actuator drive shaft.
5. Gain access to the drive through the top of the horizontal stabilizer.
  - a. Set the trim to 0 degrees.
  - b. Remove the actuator drive bearing block.
  - c. Operate the actuator to full travel in both directions, turning it with your fingers.
  - d. Movement should be easy and smooth. If it is not:
    - i. Remove the elevator.
    - ii. Remove the trim actuator through the trailing edge of the stabilizer.
    - iii. Disassemble the actuator.
    - iv. Clean the actuator and inspect it for wear per instructions in the Beechcraft Maintenance/Shop Manual.
    - v. Repair as required.

- vi. Correctly set end play with an adjusting bushing prior to installing the actuator back into the stabilizer.
- vii. Reassemble and install the actuator.
- viii. Set the actuator to the proper measurement for 0 degrees.
- ix. Attach the trim chain to the tab actuator drive.
- x. Check the cockpit indicator is at 0 degrees and the actuator rod end measurement is correct.
- xi. Install both attach bolts in the actuator drive shaft bearing block
- xii. Torque the bolts.
- xiii. Reinstall the elevator.

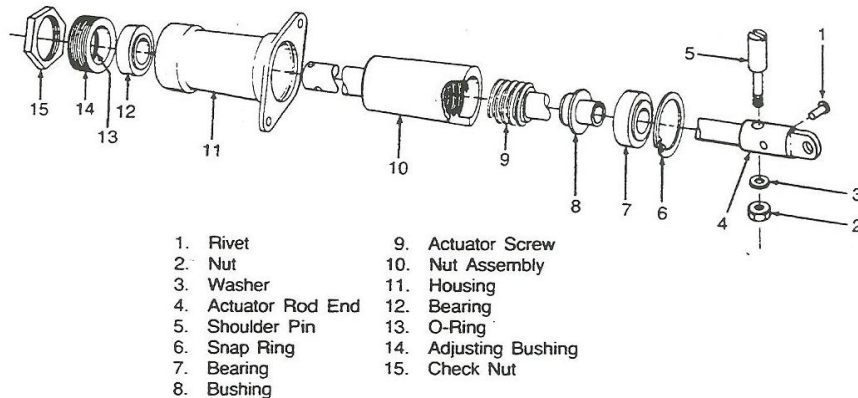
Trim actuator

**Discrepancy: There is excessive trim tab end play.**

**Tip:** End play in the rod that is not corrected will result in accelerated wear on associated parts (control horns, clevises and internal wear in the trim actuator). Worn bolts (from lack of lubrication) receive most of the wear.
