**WINGS - STRUCTURAL REPAIR ALLOWABLE DAMAGE INSPECTION**

Embraer has identified a quality escape in Structural Repair Manual (SRM) 3858, associated with discrepancies in some allowable damage instructions. Structural Repair Manual (SRM) 3858 revision 13th has already been released to address the necessary corrections.

To inspect the aircraft log book associated with allowable damage instructions for the regions affected by the quality escape and take necessary actions if applicable.

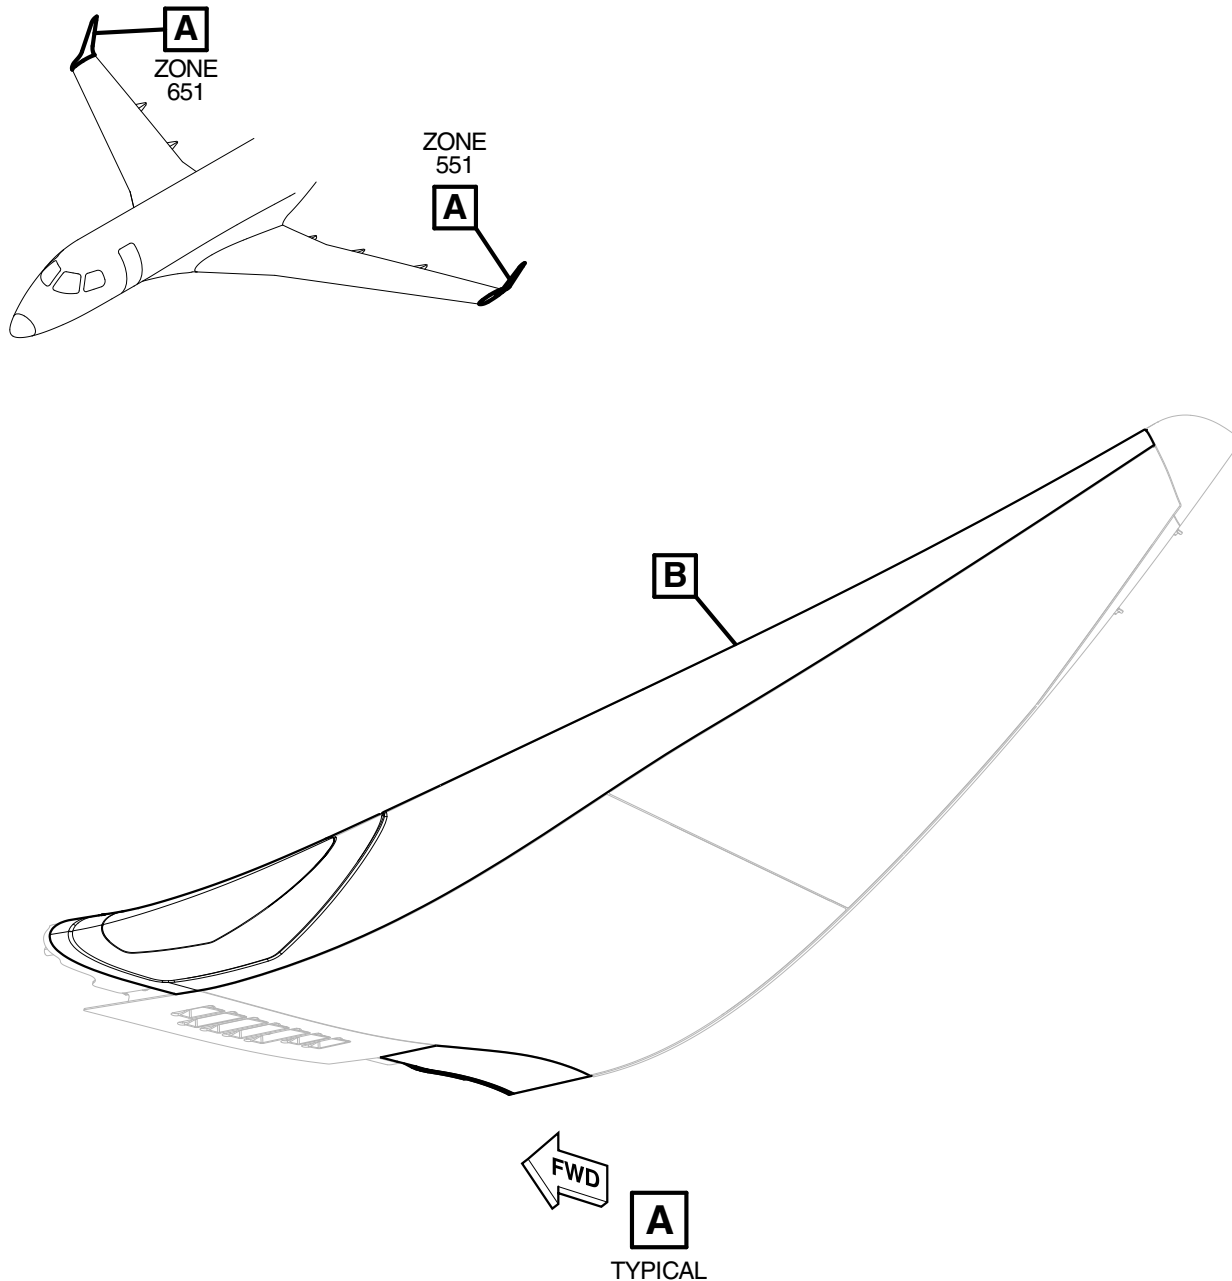
FIGURE 21 - WINGLET LEADING LOWER SKIN INSPECTION - GROUP 1, GROUP 2 AND  
POST MOD SB550-00-0011  
(Sheet 1 of 1)

**01** VERIFY IN THE AIRCRAFT LOG-BOOK WHETHER IT HAS USED ALLOWABLE DAMAGE INSTRUCTION **FOR THICKNESS REDUCTION** IN THE SHADED AREA.

- (1) Inspect the log book according to [Figure 20](#) thru [Figure 22](#), [Figure 32](#) thru [Figure 34](#) and [Figure 37](#), and do as follows:
  - (a) If there is repair associated with Structural Repair Manual (SRM) below in the log book, contact Embraer Contact Center.
