757

**Number:** 757-57A0075 RB

**SUBJECT:** WINGS - Center Wing - Rear Spar on Lower Wing Skin - Inspection

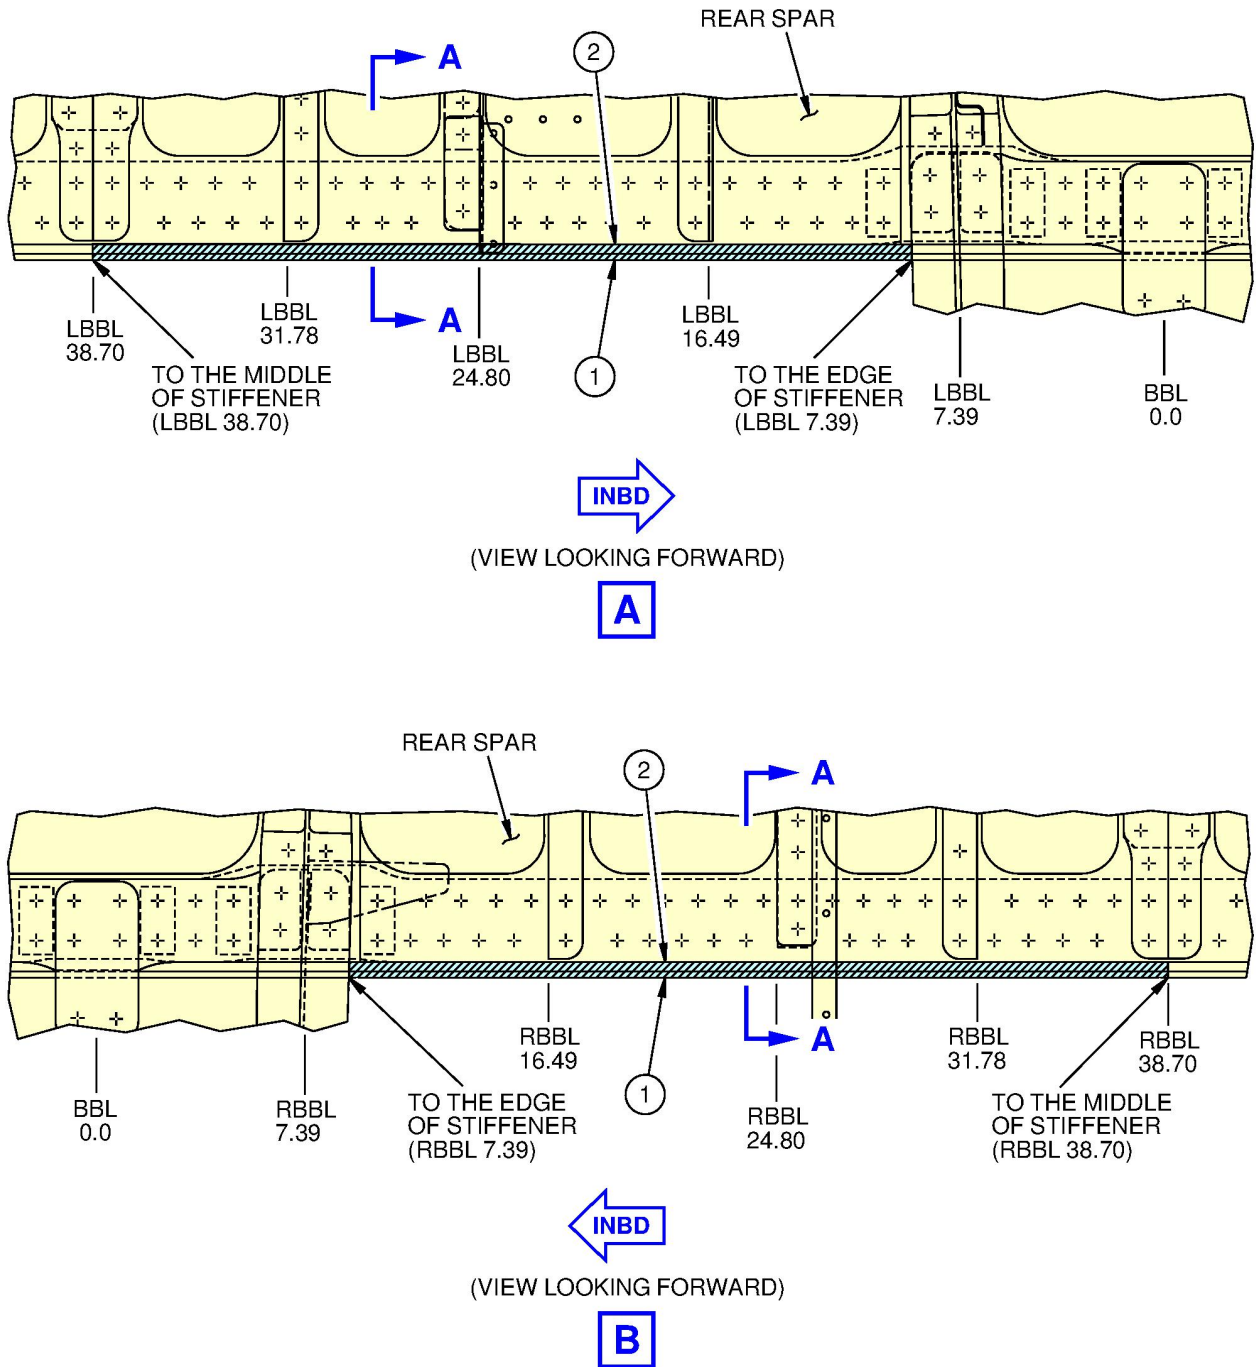
**FIGURE 1: CENTER WING BOX - REAR SPAR, LOWER SKIN AND LOWER CHORD - OPTION 1 SURFACE HFEC INSPECTION (SHEET 2 OF 3)**

| Step | Task | Name | Identification | Qty | More Data |
|---|---|---|---|---|---|
| (a) Do an external surface HFEC inspection on the edge of lower skin at the rear spar for any crack in accordance with 757 NDT Manual Part 6, 51-00-01 or 757 NDT Manual Part 6, 51-00-19. | | | | | |
| (b) Do an external surface HFEC inspection on the edge of the rear spar lower chord for any crack in accordance with 757 NDT Manual Part 6, 51-00-01 or 757 NDT Manual Part 6, 51-00-19 as an accepted procedure. | | | | | |

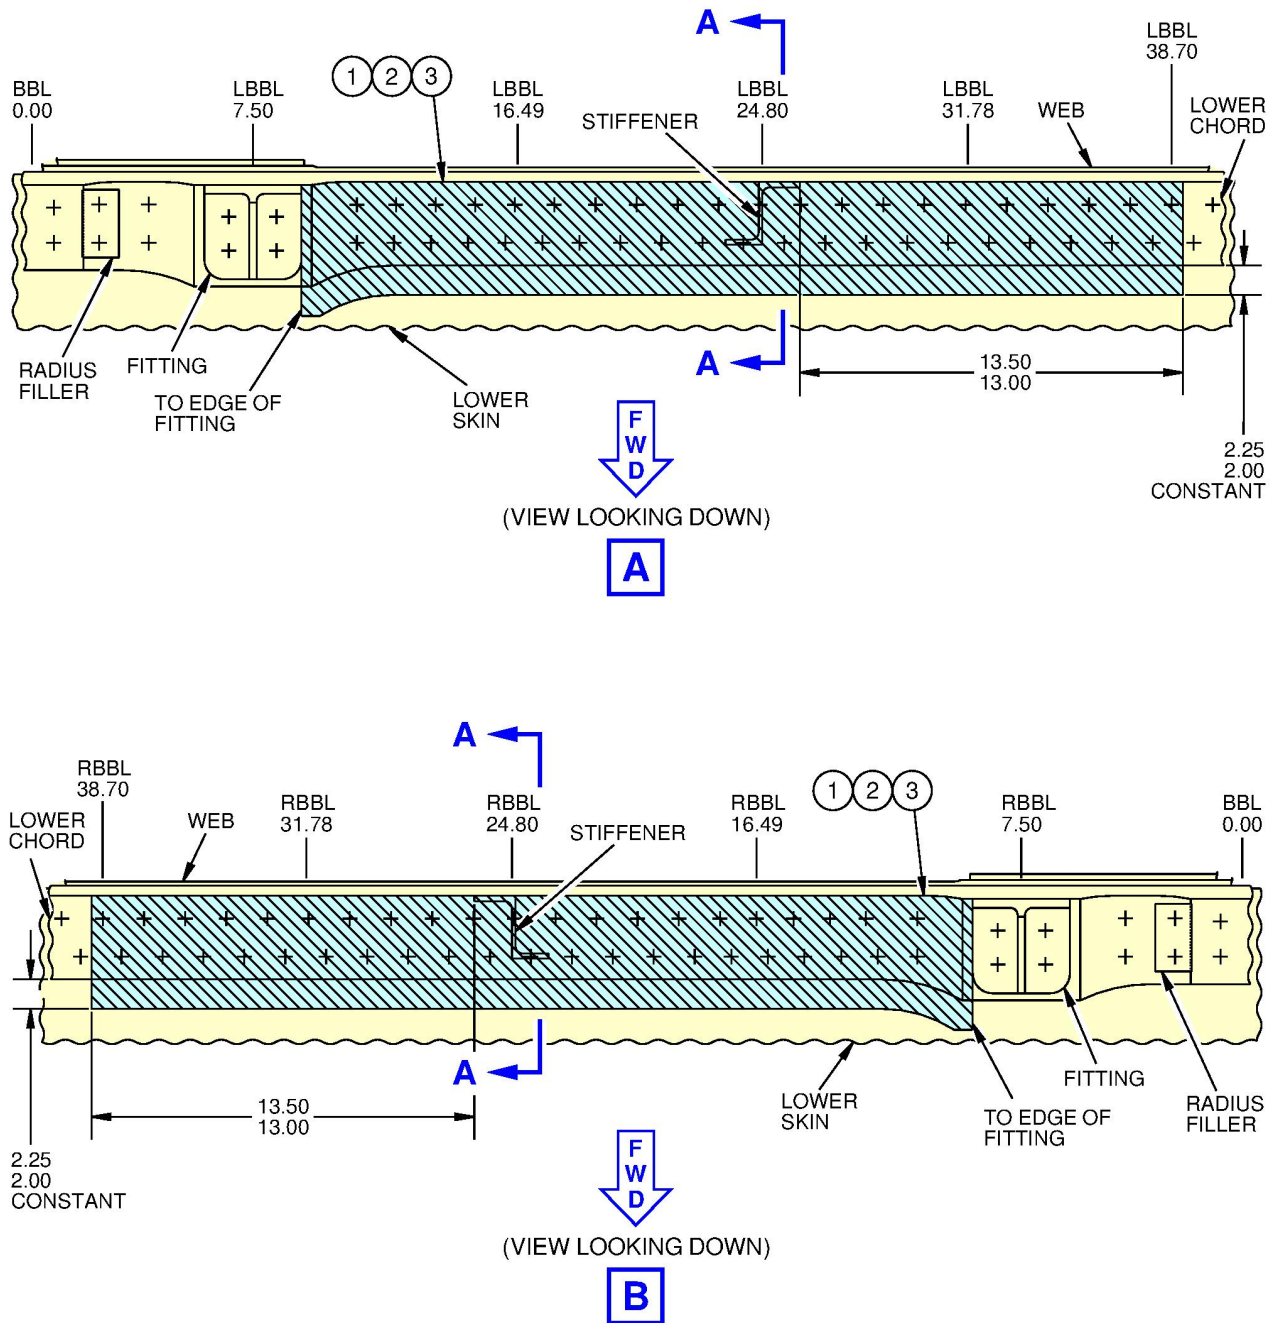
**FIGURE 2: CENTER WING BOX - REAR SPAR, LOWER SKIN AND LOWER CHORD - OPTION 2 DETAILED INSPECTION (SHEET 2 OF 3)**

(b) Do an internal detailed inspection of lower skin at the rear spar for any crack.

(c) Do an internal detailed inspection of the rear spar lower chord for any crack.

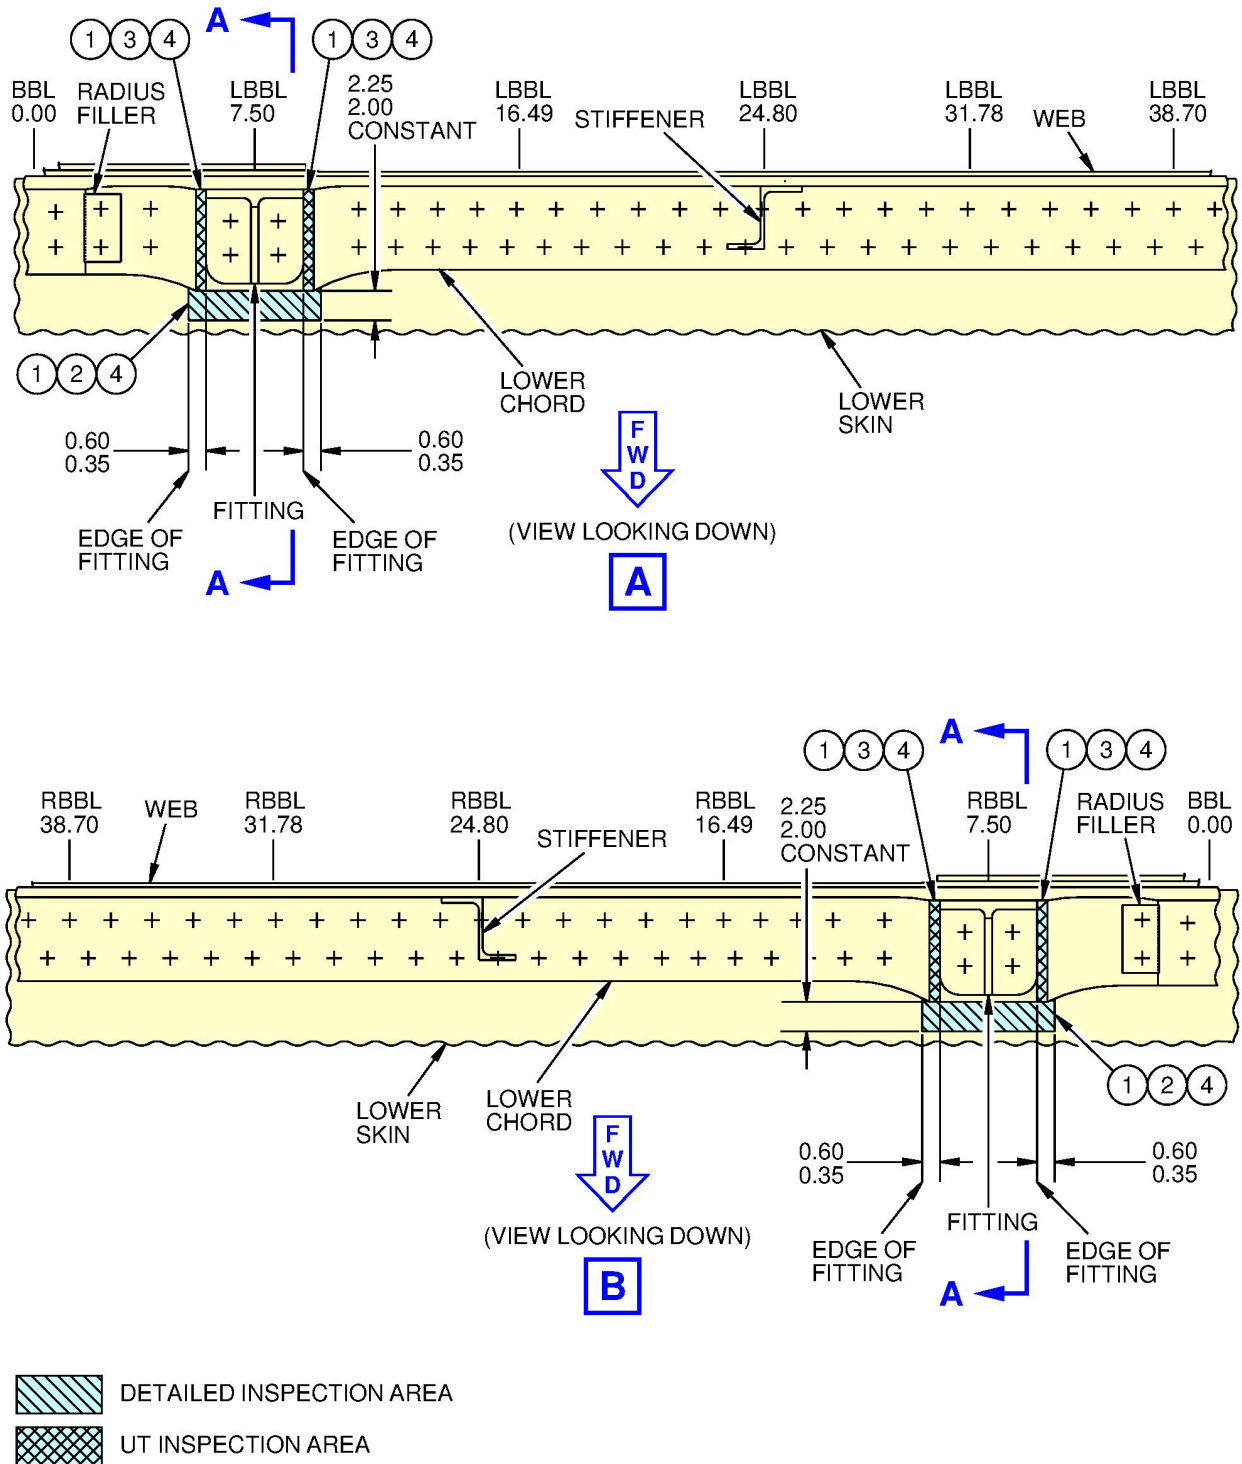
**FIGURE 3: CENTER WING BOX - REAR SPAR, LOWER SKIN AND LOWER CHORD - INTERNAL ULTRASONIC AND DETAIL INSPECTION (SHEET 2 OF 4)**

| Step | Task | Name | Identification | Qty | More Data |
|---|---|---|---|---|---|
| (b) Do an internal detailed inspection of the lower skin at the rear spar for any crack. | | | | | |
