# 757

**Number:** 757-53A0103

**SUBJECT:** FUSELAGE - Section 43 and Section 46 - Structure - Inspection and Modification of  
Open Holes on Frame Webs Between Stringers S-20 and S-25

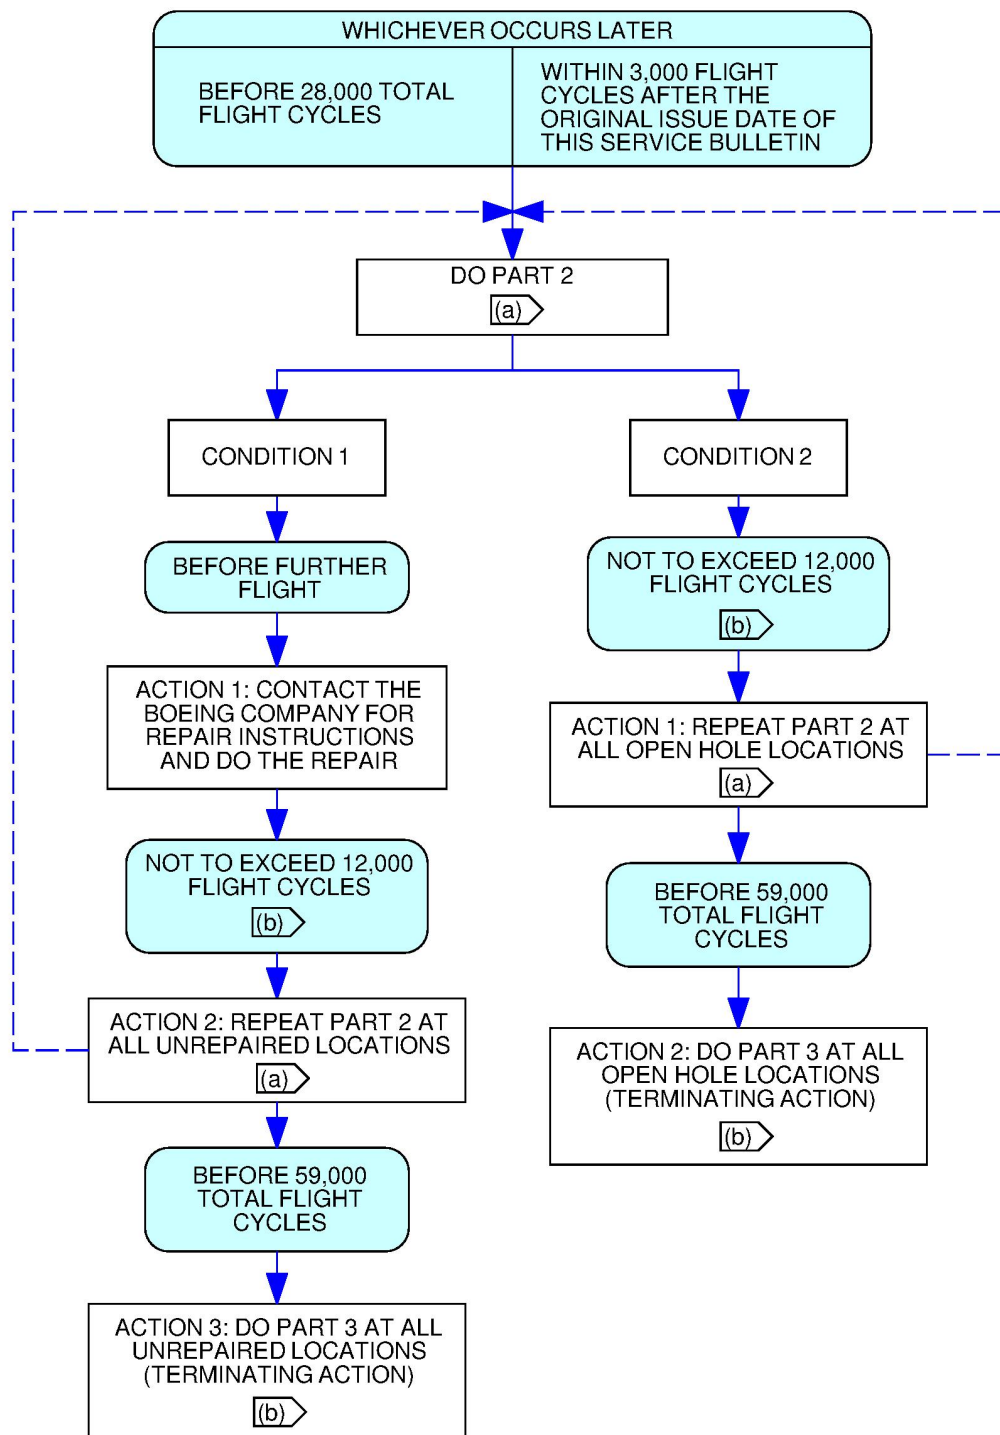
**APPENDIX A: LOGIC DIAGRAM FOR PARAGRAPH 1.E. COMPLIANCE, TABLE 1: INSPECTION AND MODIFICATION OF OPEN HOLES ON FRAME WEBS BETWEEN STRINGERS S-20 AND S-25  
(SHEET 1 OF 2)**

| Title | Description |
|---|---|
| CONDITION 1 | ANY CRACK FOUND |
| CONDITION 2 | NO CRACK FOUND |

- (1) If any crack is found at an open hole, contact The Boeing Company for repair instructions and do the repair.

If no crack is found at an open hole modify all open hole locations in accordance with FIGURE 3.
