777

**Number:** 777-29-0032

**SUBJECT:** HYDRAULIC POWER - Main Hydraulic Systems - Nose Landing Gear Alternate  
Extension Hydraulic Tube - Change

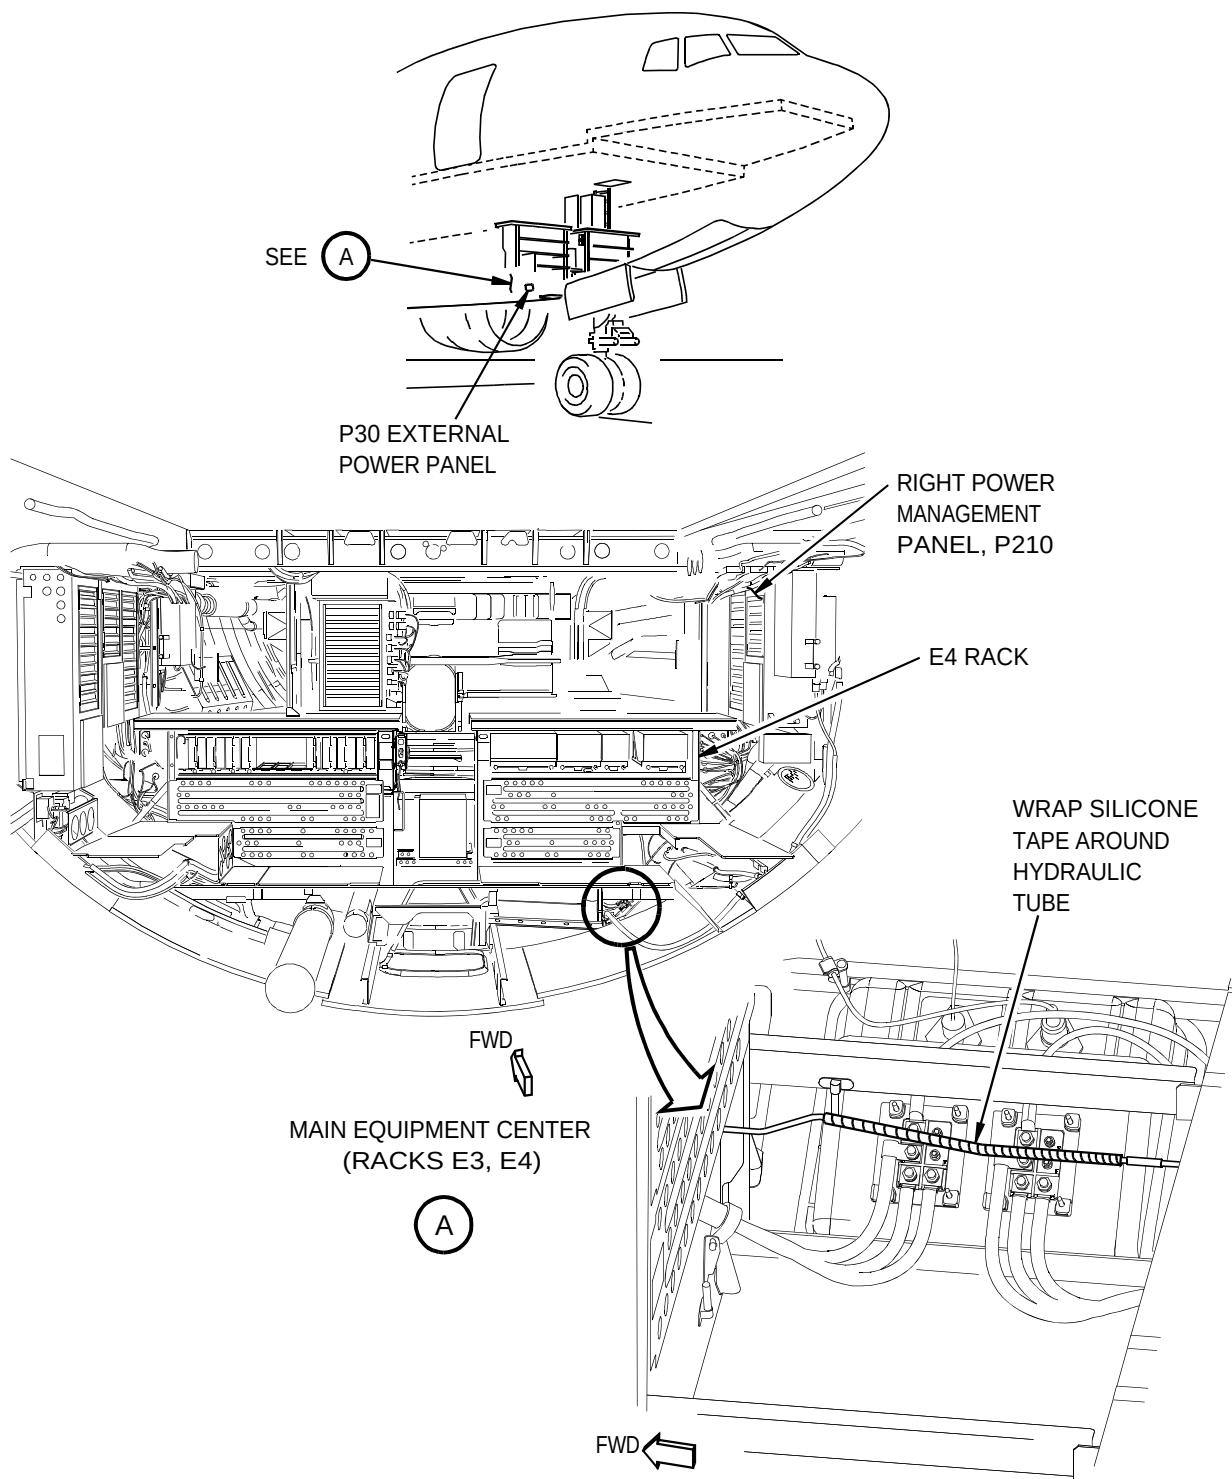
An operator reported a fire in the main equipment center after the maintenance crew connected external power. The cause of the fire was traced to a failure of an external power connector in the P30 panel, which caused high-temperature arcing and splatter of molten copper on an adjacent hydraulic tube. The molten copper splatter created a hole in the tube, and hydraulic fluid sprayed into the power connector and caught on fire.

1. Remove primary and secondary external power from the airplane. Refer to 777 AMM 24-22-00 as an accepted procedure.
2. Get access to and change the hydraulic tube as given in Figure 1.
3. Put the airplane back to a serviceable condition.
