**SERVICE BULLETIN****N° 139-783****EMERGENCY ALERT****DATE:** April 10, 2024**REV. :** A November 6, 2024

**TITLE****ATA 32 – MLG SHOCK ABSORBER INSPECTION****REVISION LOG**

**INSPECTION OF SHOCK ABSORBER PISTON ROD EYE END**

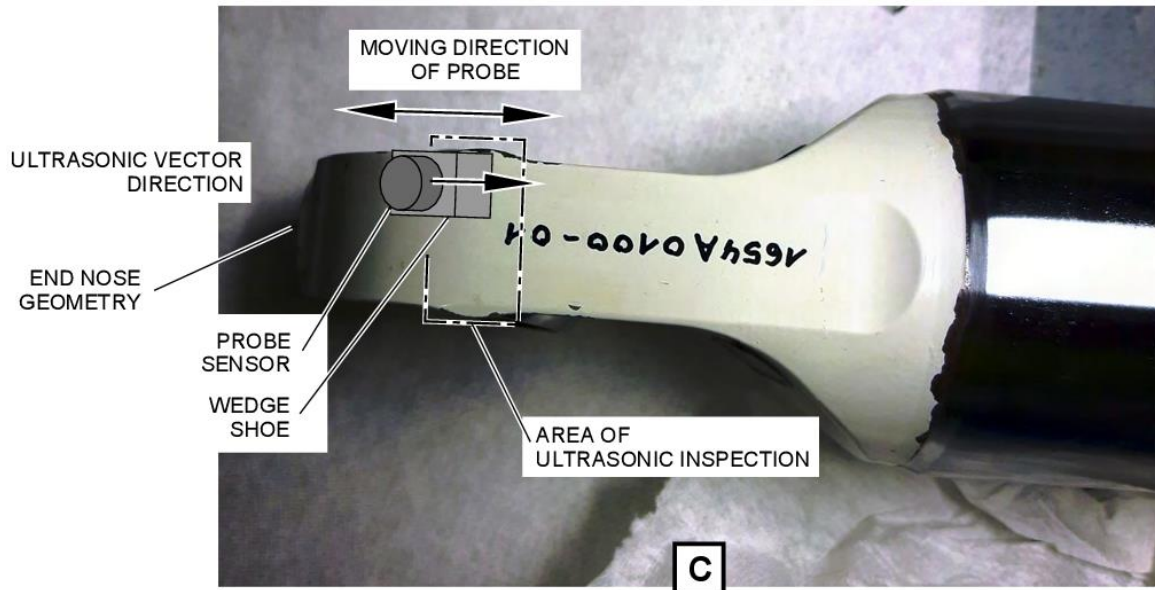
- (a) The Inspection Area is defined in [Figure 2](#) and [Figure 3](#). Two separate Inspection Areas are to be observed, one at the UPPER side and one at the LOWER side of the piston rod eye end. With the landing gear installed on the helicopter the Inspection Area is partially obstructed by surrounding structure. An inspection mirror and an inspection flashlight is inevitable to gain visibility access to the Inspection Area.
