**SERVICE BULLETIN****REVISION NOTICE****FLIGHT CONTROLS - NON-DESTRUCTIVE INSPECTION (NDI) OF 374461-5, -7, AND -11 ELEVATOR BOOSTER FOR ACTUATOR CRACKS**

**SERVICE BULLETIN****FLIGHT CONTROLS - NON-DESTRUCTIVE INSPECTION (NDI) OF 374461-5, -7, AND -11 ELEVATOR BOOSTER FOR ACTUATOR CRACKS**

**382-27-51**

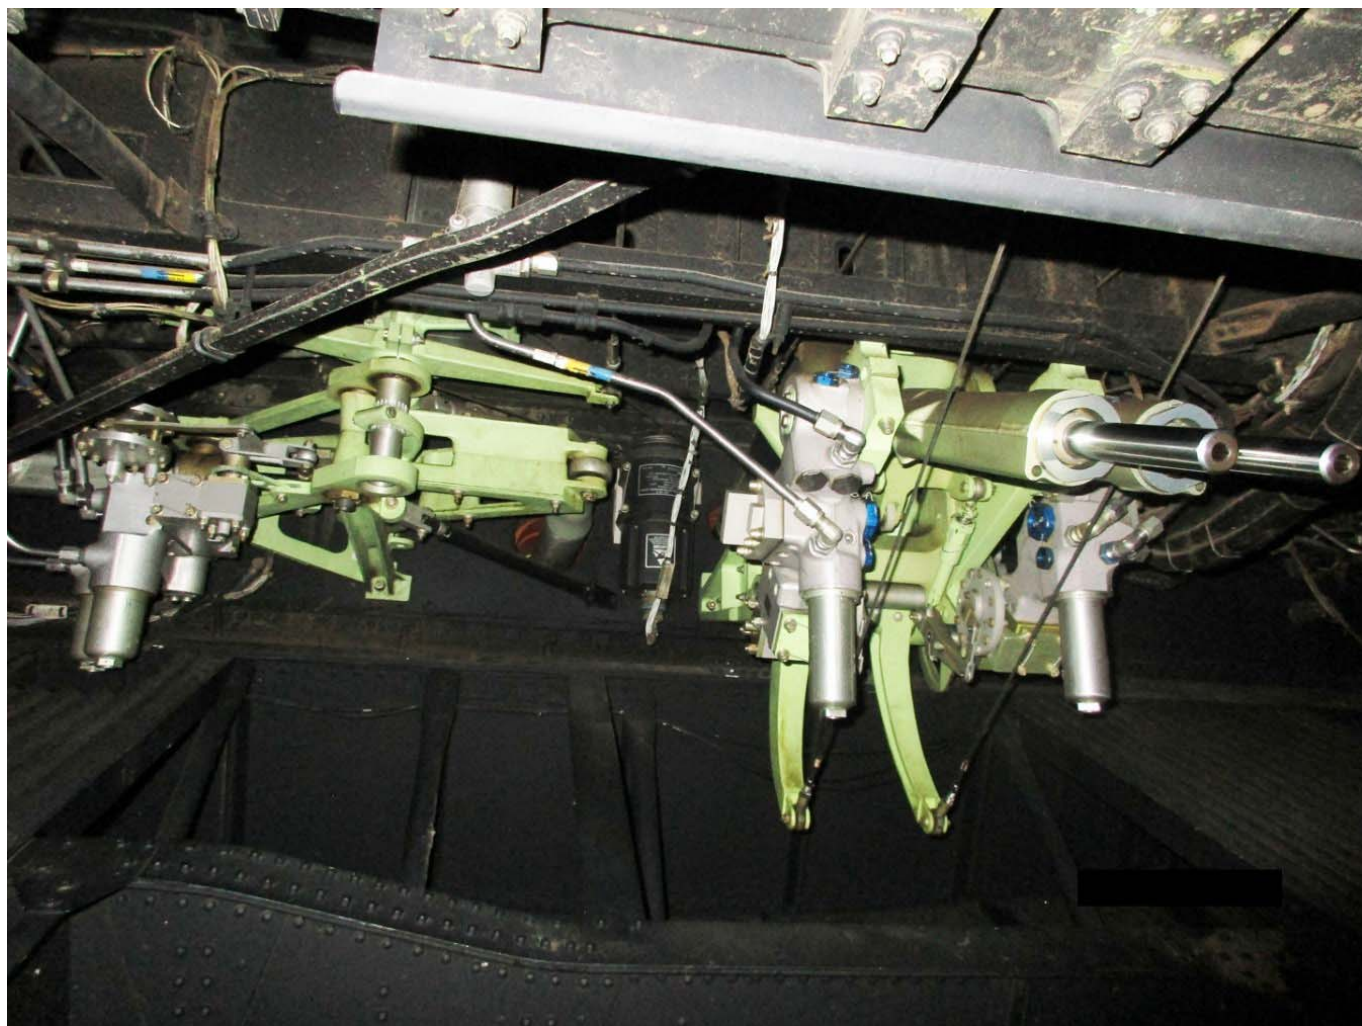
Elevator Booster Assembly as Installed on Aircraft (View Looking Aft and Up from the Cargo Ramp)  
Figure 1

1. **PURPOSE:** Perform nondestructive inspection of the elevator booster assembly actuator (Part No. 5C5803) at the forward-most end to detect cracking along the fluid transfer bore, left and right cylinders. See Figure 1 for the elevator booster assembly installed on-aircraft and Figure 2 for the inspection areas of interest.

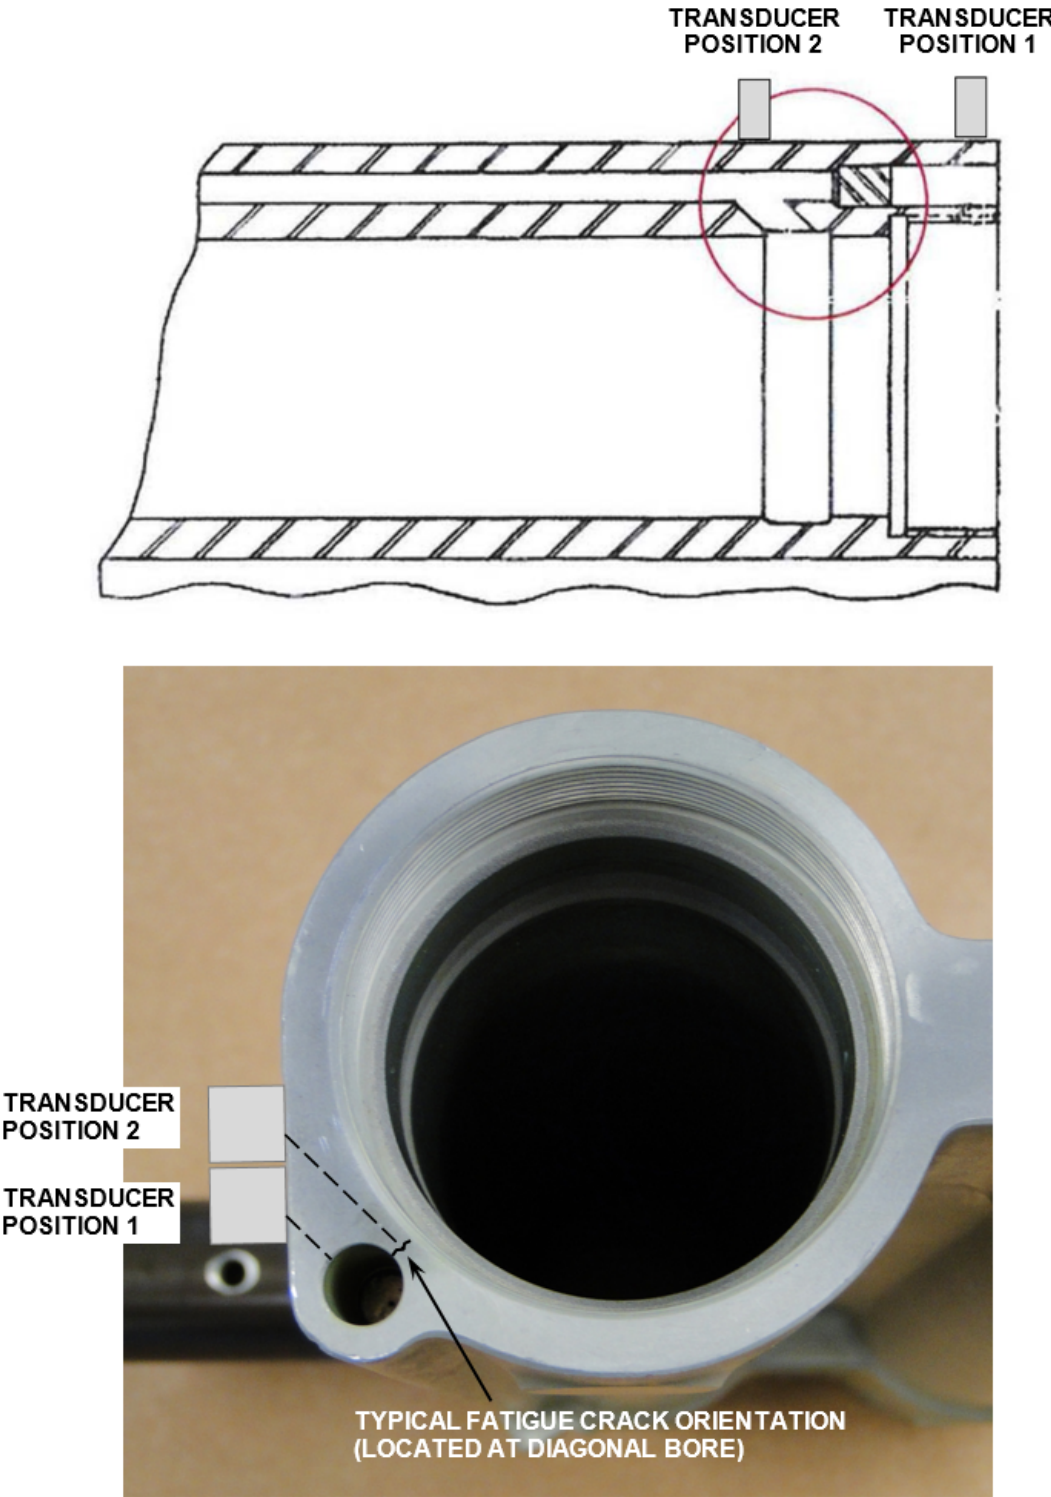
Transducer Positions for Calibration at Diagonal Bore  
Figure 4

- (b) Place the transducer at Position 2 between the two marked lines. See Figure 4. Using the raised forging seam at the cylinder centerline as a backstop, slide the transducer fore/aft while observing the signal response from the diagonal bore at approximately 55 percent FSW (5.5 TB).

- (a) Couple the transducer at Position 2 and maximize the signal response from the diagonal bore. See Figure 4.
- (b) Using the raised forging seam as a guide, scan forward and aft of the diagonal bore markings on the housing. Measured from the forward-most end of the cylinder, scan a distance from 1.18 to 2.75 inches (30 to 70 mm) along the cylinder. See Figure 3 for the typical scanning zone.

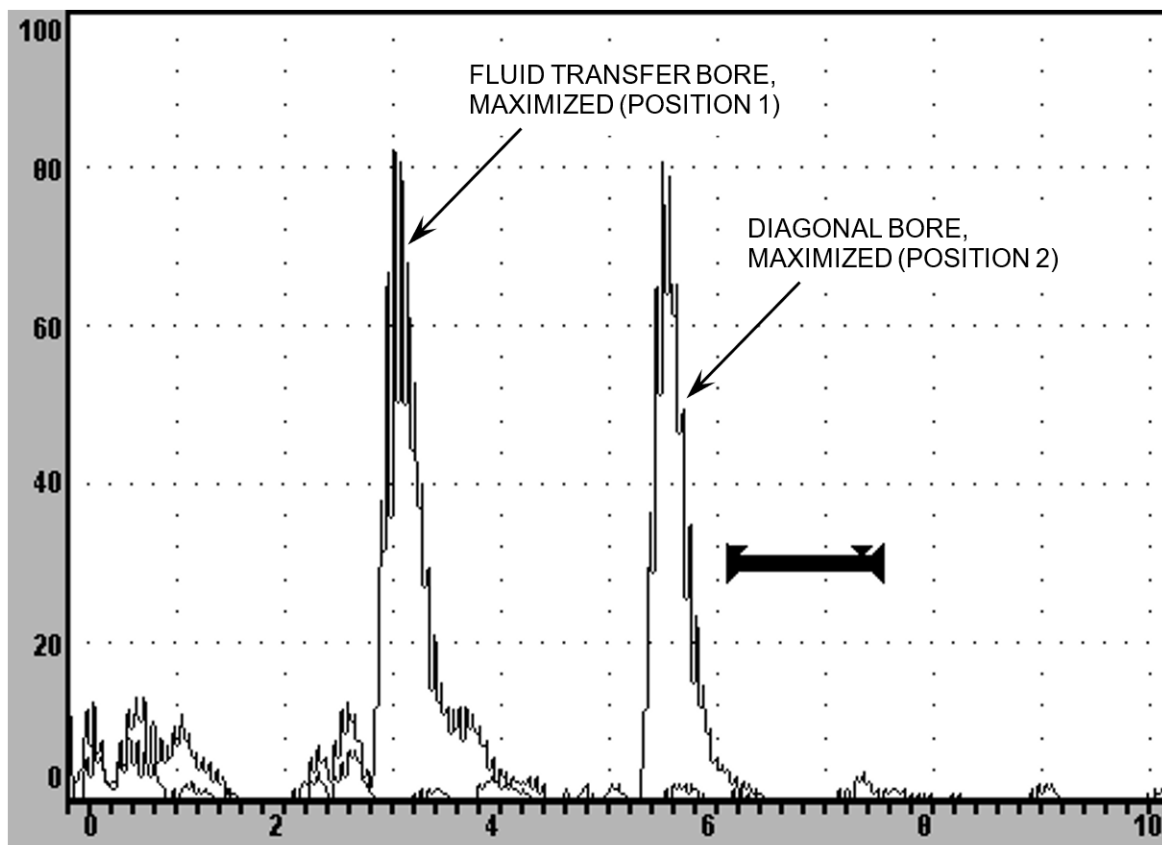
Ultrasonic Signal Responses During Calibration and Inspection  
Figure 5, Sheet 1 of 3

- (4) Maximize the signal response from the fluid transfer bore and adjust the GAIN, as necessary, to achieve an 80 percent full screen height (FSH) signal response from the bore. See Screen Display 1 in Figure 5, Sheet 1, for the maximized signal response after adjustment.

- (c) Maximize the signal response from the diagonal bore and adjust the GAIN, as necessary, to achieve an 80 percent FSH signal response from the diagonal bore. See Screen Display 1 in Figure 5, Sheet 1, for the maximized signal response after adjustment.

Screen Display 1: Maximized Signal Responses from Fluid Transfer Bore and Diagonal Bore.
