**Service Bulletin**

June 18, 2007

SEB07-2  
Revision 2**TITLE****ENGINE MOUNT BRACKET INSPECTION****EFFECTIVITY**

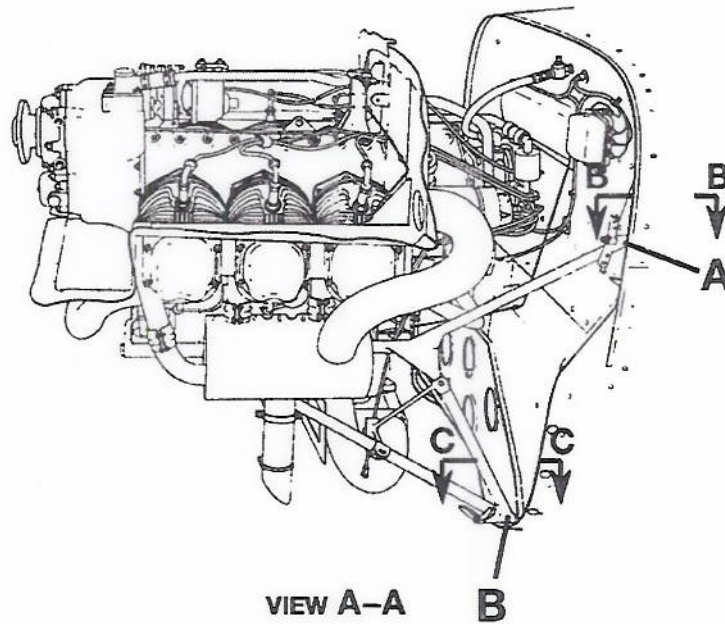
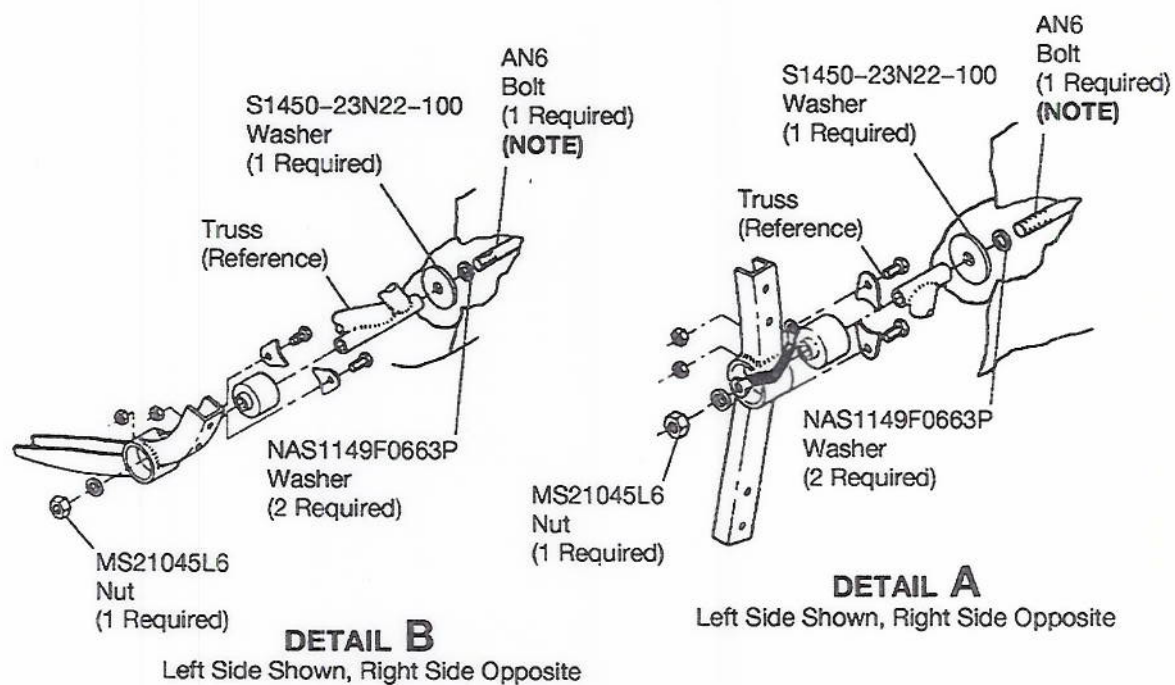
Figure 1. Engine Mount Bracket Inspection (Sheet 1)

- D. (Refer to Figure 1, View D-D.) Look carefully for a deformed or cracked left 0513132-11 Upper Mounting Bracket.
  - (1) If you do find deformities or cracks, go to Step 5E.

Reports have been received of cracks being found in some upper and lower engine truss mounting brackets that are installed behind the firewall. This Service Bulletin provides instructions to do an inspection of the brackets, and if necessary, to replace the brackets. Non compliance with this Service Bulletin could result in having less than the desired structural integrity of the upper and lower engine truss mounting brackets.

- (2) If you do not find deformities or cracks, go to Step 6.
- E. (Refer to Figure 1, View B-B.) Remove the left 0513132-11 Upper Mounting Bracket from the 0513132-7 Upper Left Stringer and the airplane skin.

- (9) Apply Alodine to bare metal.
  - (10) Do a touch-up of the paint as necessary.
  - (11) (Refer to Figure 1, Detail A.) With the AN6 Bolt, S1450-23N22-100 Washer, two NAS1149F0663P Washers, and MS21045L6 Nut, attach the upper left engine truss to the left 0513132-11 Upper Mounting Bracket.
