**Rev.: # 2**

**PURPOSE: CHECKING THE STRUCTURAL INTEGRITY OF THE FRONT LONGITUDINAL SPARS OF THE WINGS OF THE PIPER PA-25 Series, IN ORDER TO PREVENT CATASTROPHIC FAILURES**

THIS PUBLICATION of SB # 25-57-11 R2 (Revision # 2) REPLACES THE PREVIOUS "Original and R1"

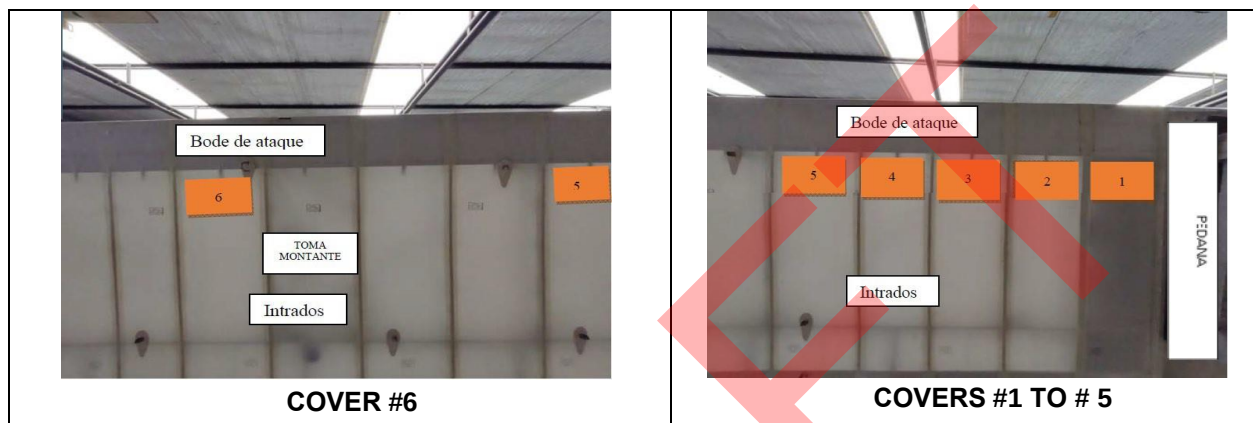
**PHOTOGRAPHS indicating the six (6) inspection cover areas**

To perform the actions in this service bulletin, six (6) inspection covers (Kit P/N 96001-100) must be installed on each half-wing in the locations shown below:

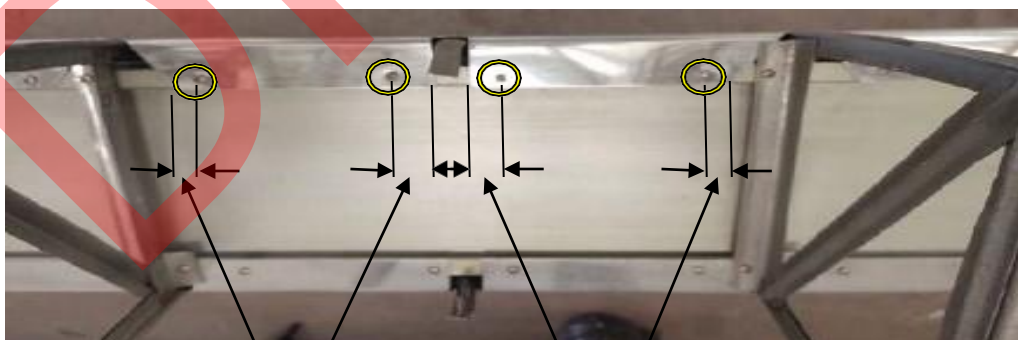
**Typical installation of screws on leading edge flaps**

- 5 Lift the flaps from the leading edge, clean the flange with a mild detergent, dry, and check. There should be no more than 4 holes between ribs (see typical installation of screws in leading edge flaps).

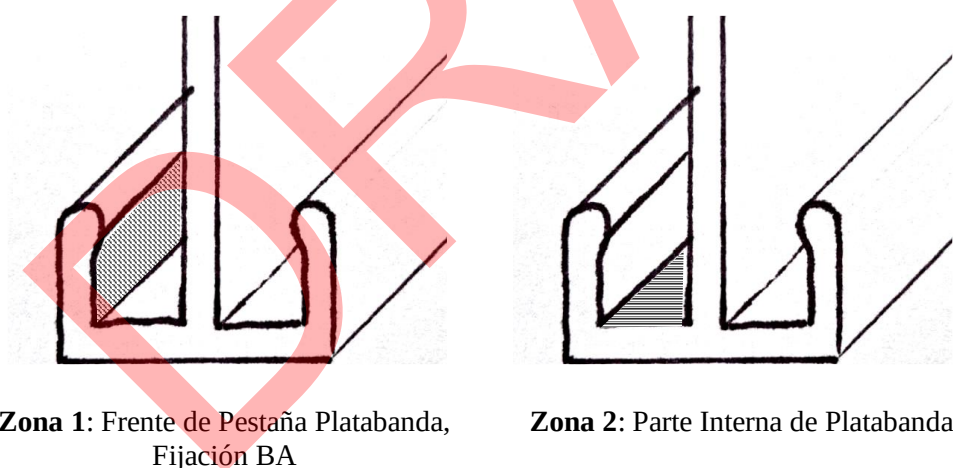
**Figura 1 – Áreas de Inspección de Larguero Delantero PA-25**

(1) Las áreas específicas de inspección sobre la solapa superior/ inferior del larguero son resaltadas y mostradas abajo en la **Figura 1**.

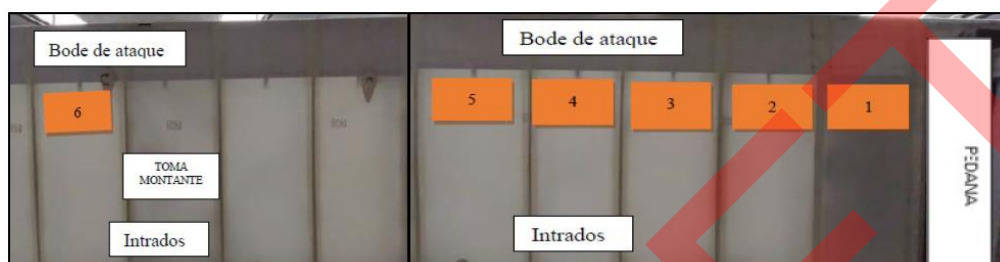
**Figura 4A** – Zona de Acceso por Tapas de Inspección según SB25-57-11

Ingresa a las zonas de platabanda SUPERIOR por los accesos de las tapas de inspección N° 1, y N° 2, e ingrese a las zonas de la platabanda INFERIOR por el acceso de la tapa de Inspección N° 6 en el intradós del ala, según SB25-57-11.

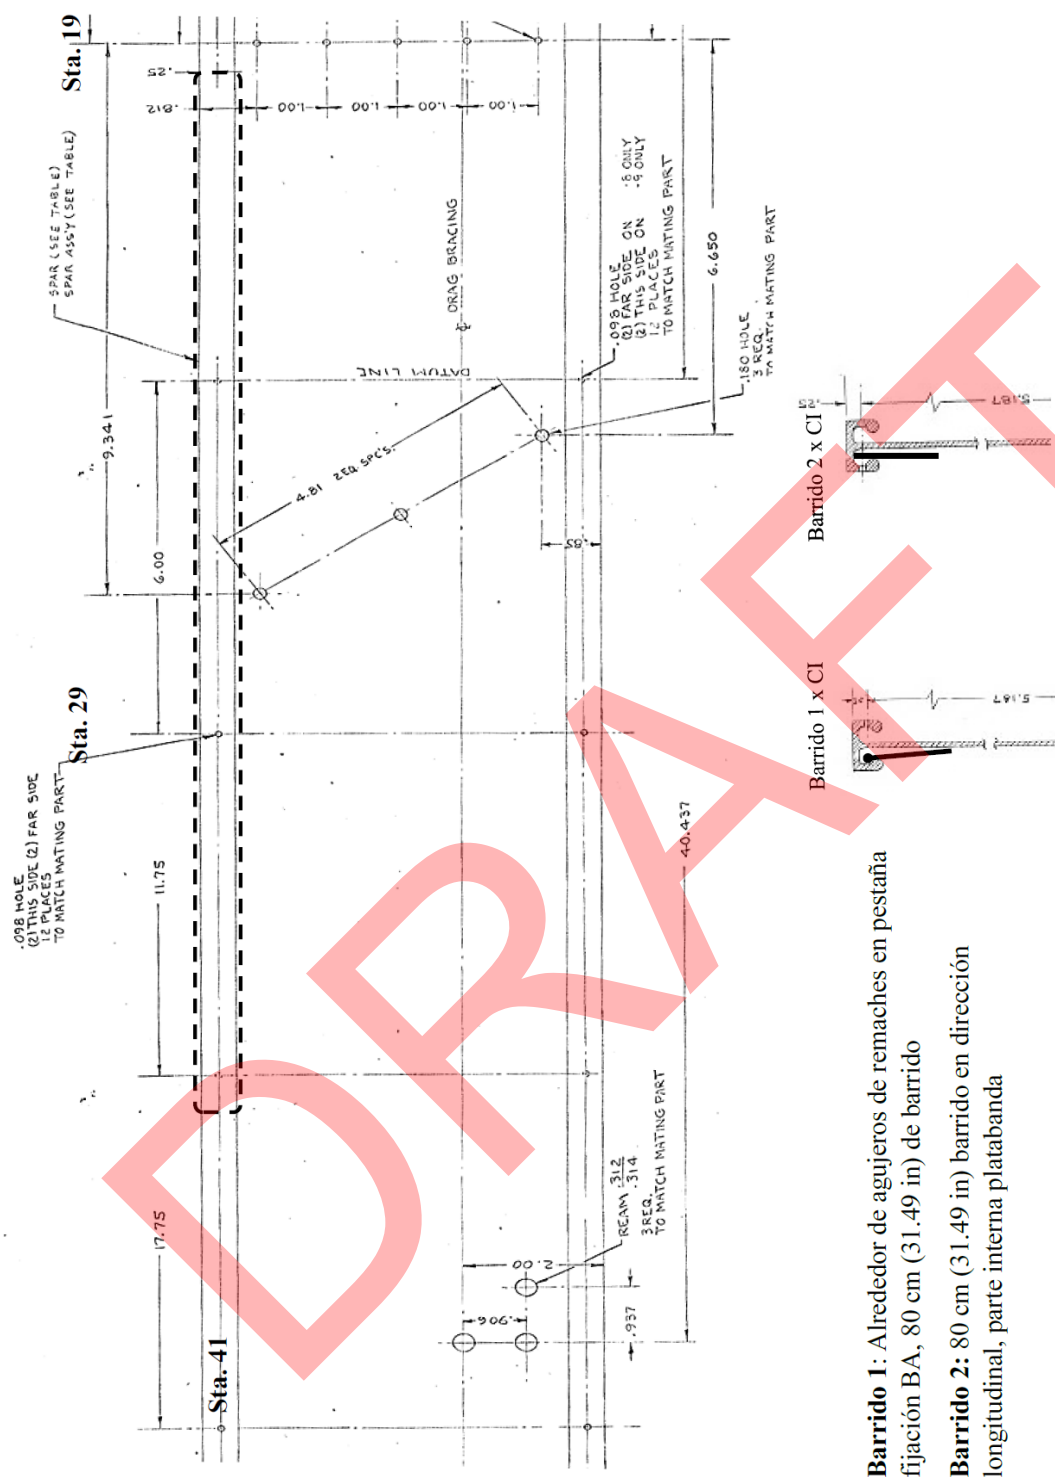
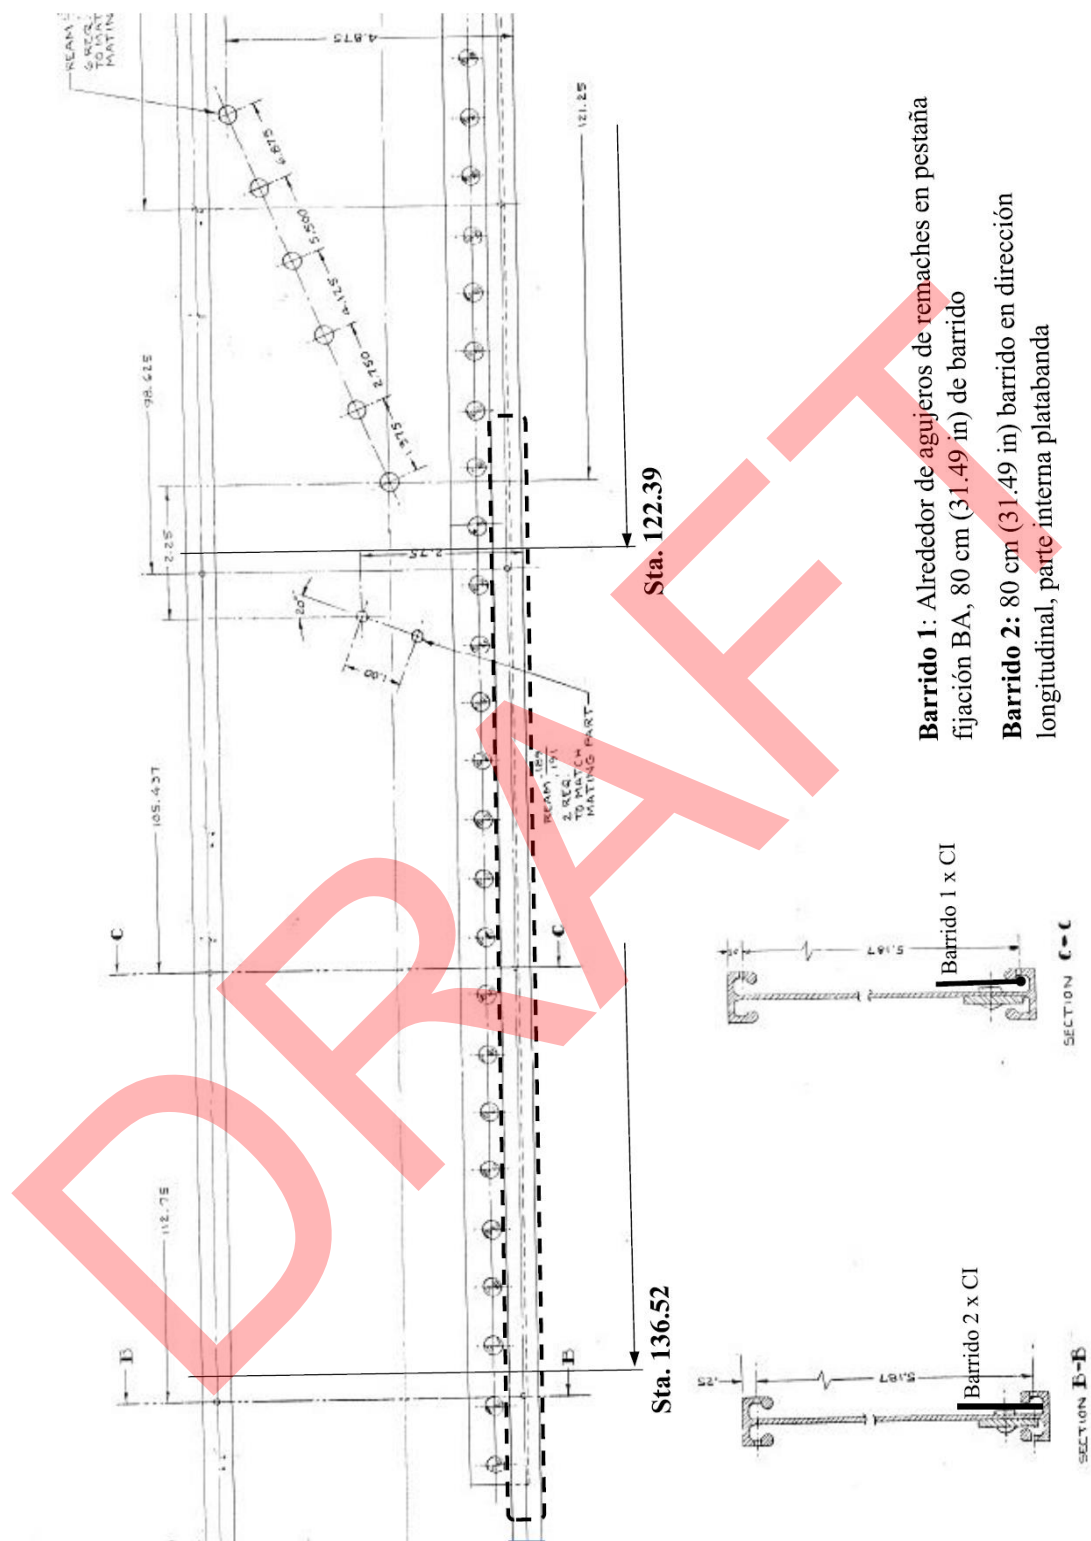
**Figura 7D – Localización Platabandas**

El primer barrido debe hacerse ingresando por las **tapas N° 1 y N° 2**, apoyando la sonda SPO-3611 en el lateral interior de la **pestaña platabanda superior**, e ingresando por la **tapa N° 6**, apoyando la sonda SPO-3611 en el lateral interior de la **pestaña platabanda inferior**, sobre todo el largo y entre las costillas adyacentes, con especial atención en los límites de los orificios existentes.

El segundo barrido debe hacerse ingresando por las tapas N° 1 y N° 2, sobre todo el largo y entre costillas adyacentes, apoyando la sonda TPEN9100-6 en la base interior platabanda superior, e ingresando por la tapa N° 6, sobre todo el largo y entre las costillas adyacentes, apoyando la sonda TPENFLX-6 en la base interior platabanda inferior.

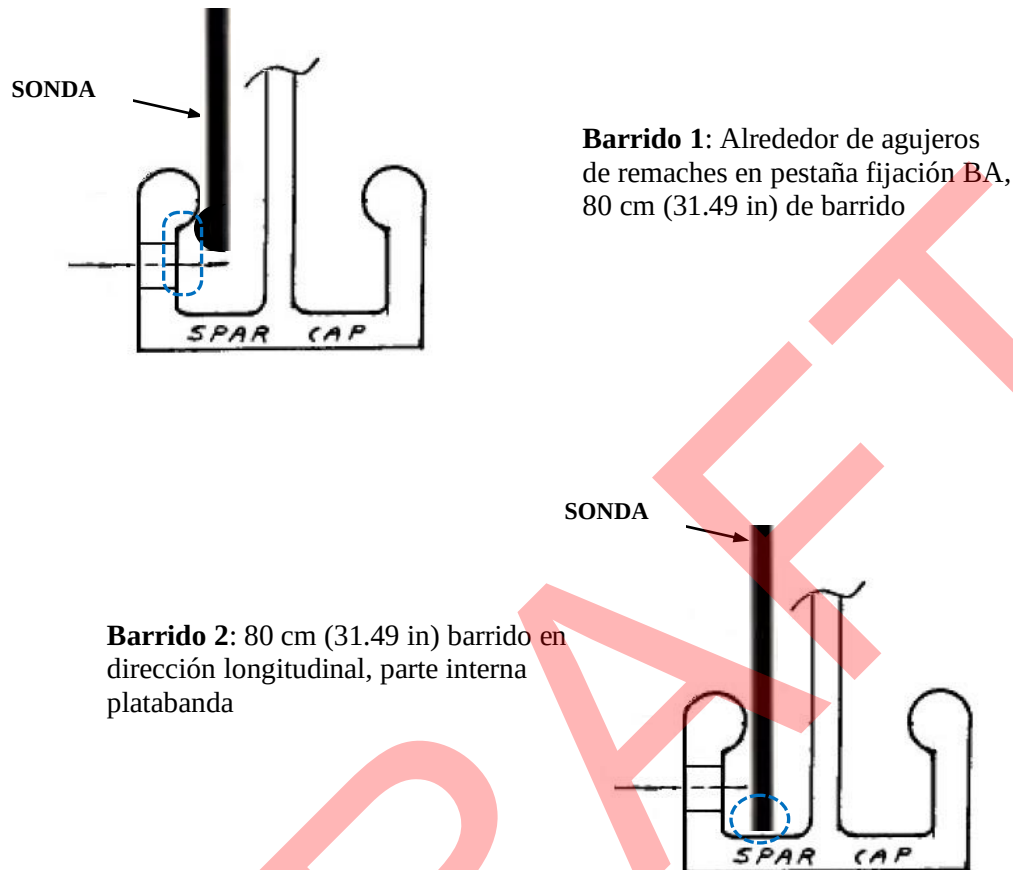
**Figura 7E** – Áreas de Inspección y Barridos

- E. El barrido propiamente dicho de las áreas a inspeccionar, mostrado en **Figura 7E**, debe extenderse 80 cm (31.49 in) prestando particular atención a los alrededores de agujeros, marcas o "lastimaduras" de herramientas, golpes, melladuras, y pits de corrosión.
