American Bonanza Society Air Safety Foundation

# **Flight Controls, Flaps and Trim System Inspection, Repair and Rigging Guide**

For Beechcraft Bonanza, Debonair, Baron and Travel Air

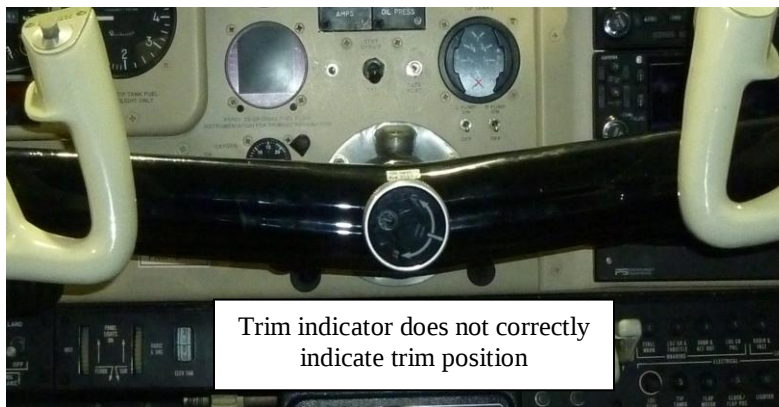
**Discrepancy:** Aileron trim indicates left or right when the control wheel is centered (Models 35; Be33; Be 36 except E-1946, E-2104, and E-2111 and after; Model 36TC except EA-320 and EA-389 and after).

1. Remove the indicator placard retaining ring with a scribe or “o” ring pick.
2. Reposition the indicator to 12 o’clock (trim centered) position.
3. Reinstall the retaining clip.

4. Check that the trim indicates correctly.

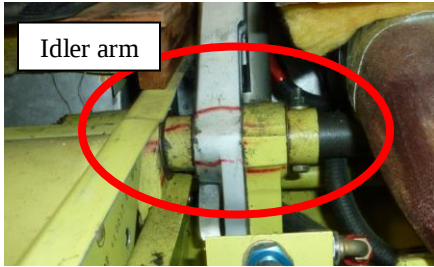
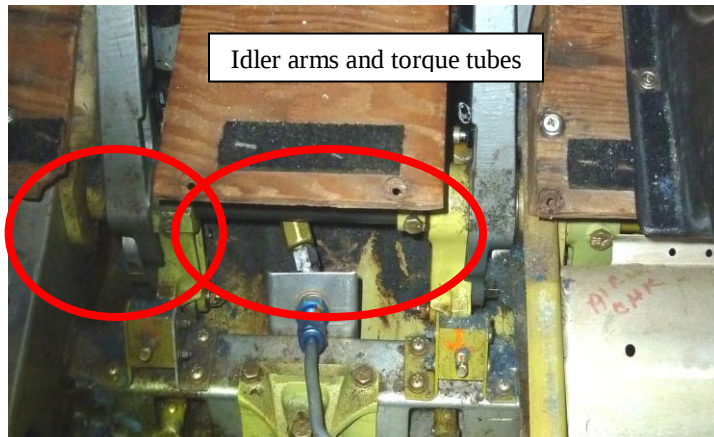
### Discrepancy: Wear or elongation of rudder pedal pivot bolt holes.

**Tip:** Worn or elongated pivot holes are usually the result of using the brakes to steer the airplane.

5. To replace or relocate pedal arms from the copilot side to the pilot side:
  - a. Place the aircraft on jacks.
  - b. Note the left rudder pedal torque tube has a steering bell crank and aileron/rudder bungee bell crank on the inboard end. The right torque tube has a nose landing gear retract rod idler arm attached on the inboard end.

- c. Remove the center console cover and floorboard for easier access to the torque tube ends.
  - d. Remove the bolts from the torque tube. There is one bolt on the inboard side of each rudder pedal.
  - e. Slide the torque tube inboard to remove the rudder pedal arms.
  - f. Use the same procedure for the pilot side, except the bolt must be removed from the steering bell crank. Move the torque tube inboard and remove the rudder pedal arms.
  - g. Install replacement arms or relocate the arms on the torque tube.
  - h. Reinstall the bolts.

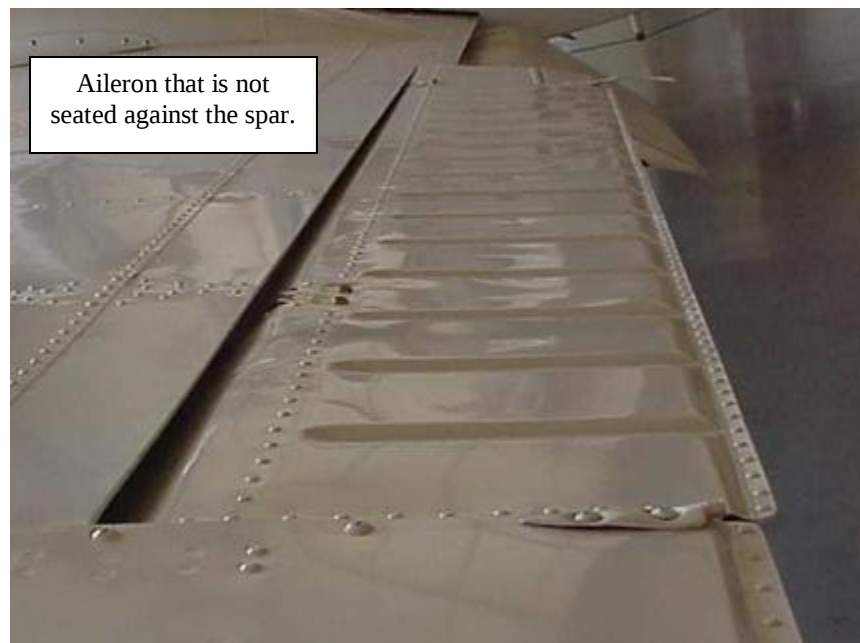
**Discrepancy: The aileron hinge bracket is not seated against the aileron spar.**

**Tip:** In most cases it's the aileron outboard hinge bracket lower attach flange that is discovered not seating against the spar. Since there is only a small load on the surface no damage occurs to the spar or bracket. The condition is more obvious seen from the trailing edge. The gap between the trailing edge skin and aileron will be considerably wider towards the unattached bracket when this condition occurs.

1. Remove screws on the unattached side of bracket.
2. Seat the hinge bracket against the spar.
3. Reinstall the screws.

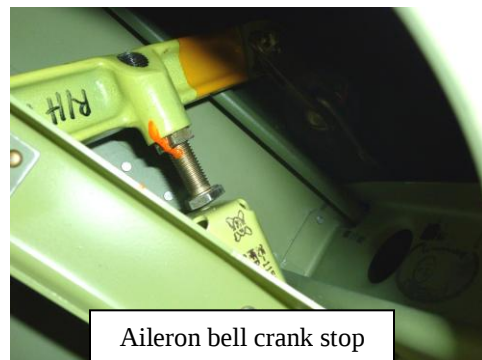
**Discrepancy: The aileron bell crank stops do not contact the stops in both wings.**

1. Check the aileron bell crank travel stop positions up and down per the Beechcraft Maintenance/Shop Manual to ensure the ailerons are deflecting to full travel.
2. Adjust the travel stops per instructions in the Beechcraft Maintenance/Shop Manual.

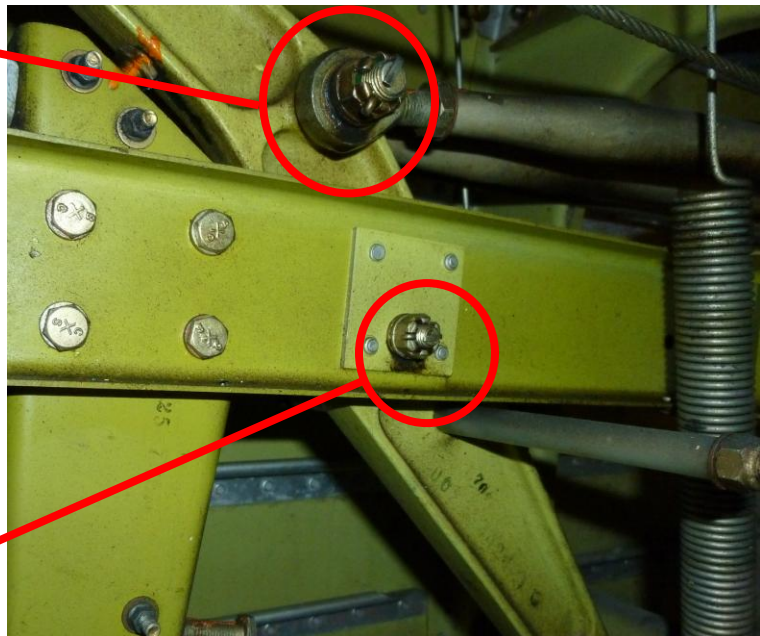
**Discrepancy: The left and right elevator trailing edges move up and down independently when pressure is applied.**

1. Check elevator push-pull rod attach bolt at the elevator bell crank.
2. If the attach bolt is loose:
  - a. Remove the bolt to check for hole elongation.
  - b. If the hole is good, reassemble and tighten the attach bolt tightly against the elevator control rod ends.
  - c. Safety the nut with a cotter pin.
3. Check the elevator bell crank hinge bolt for looseness and wear. If there is significant movement:
  - a. Remove the bolt and check for hole elongation.
  - b. If the hole is good, reassemble and tighten the hinge bolt.
  - c. Safety the nut with a cotter pin.

**Tip:** Usually the bolt can be tightened on the bushing to remove the play.

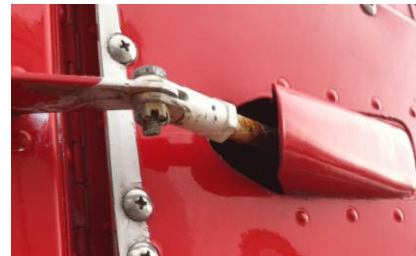
**Discrepancy:** The Baron/Travel Air rudder trim actuator has excessive free play.

1. Check the bushing in the rudder trim tab horn for wear. Replace if worn.
2. Check the trim actuator attach bolt for wear. Replace if worn.
3. Tighten the bolt on the clevis. You should be able to rotate the bolt with a firm grip.

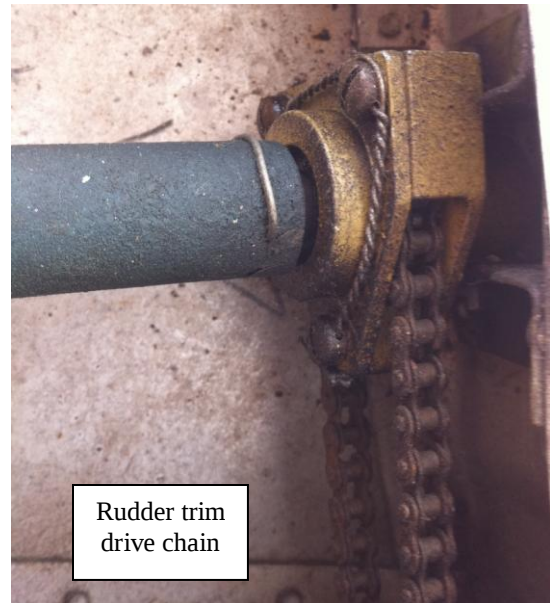
**Discrepancy: The rudder trim actuator drive chain is binding.**

1. Check the trim drive chain for dirt build-up.
2. Clean the chain with cleaner degreaser.
3. Lubricate the chain with light oil or LPS2

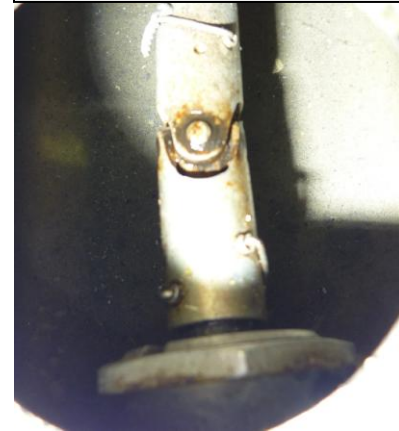
Trim universal joint

**Tip:** Often a step will wear in the brass Acme thread nut in the actuator. Grease may be dirty, old, and caked.

3. Check the trim actuator for freedom of movement.
4. Disconnect the drive chain from the actuator drive shaft.
5. Gain access to the drive through the top of the horizontal stabilizer.
  - a. Set the trim to 0 degrees.
  - b. Remove the actuator drive bearing block.
  - c. Operate the actuator to full travel in both directions, turning it with your fingers.
  - d. Movement should be easy and smooth. If it is not:
    - i. Remove the elevator.
    - ii. Remove the trim actuator through the trailing edge of the stabilizer.
    - iii. Disassemble the actuator.
    - iv. Clean the actuator and inspect it for wear per instructions in the Beechcraft Maintenance/Shop Manual.
    - v. Repair as required.
