# ALERT SERVICE BULLETIN

NO. 407-10-93

**MODEL AFFECTED:** 407

**SUBJECT:** TAILBOOM ATTACHMENT HARDWARE,  
REPLACEMENT OF.

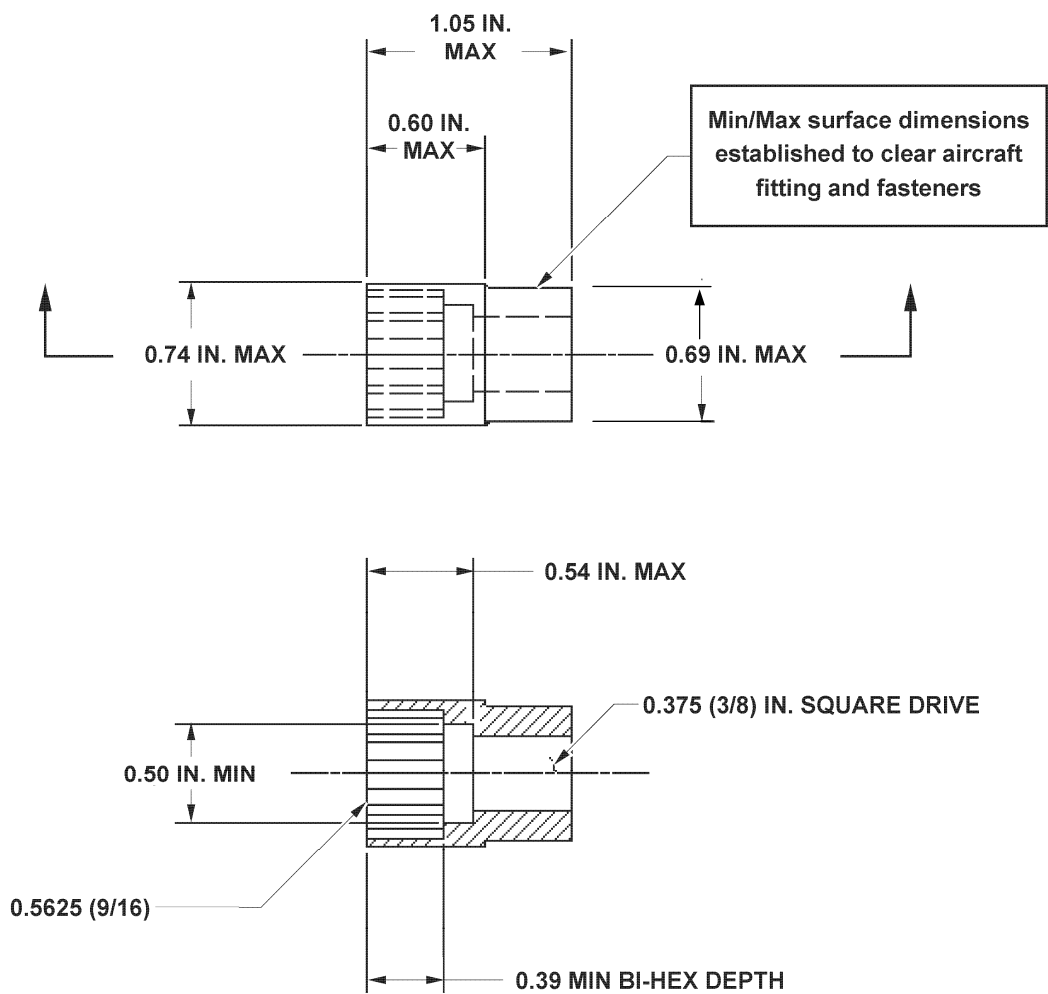
FIGURE 1: Maximum and minimum reference dimensions of socket

**Note:** an equivalent tool may be locally fabricated using a commercial 12-point socket. Refer to Figure 1.
