## **INSTRUCTIONS FOR CONTINUED AIRWORTHINESS**

### **ICA MANUAL No. VMM-MR-206B-503**

**Main Rotor Blade Assembly 20635000-501  
Eligible for Installation on Model 206B**

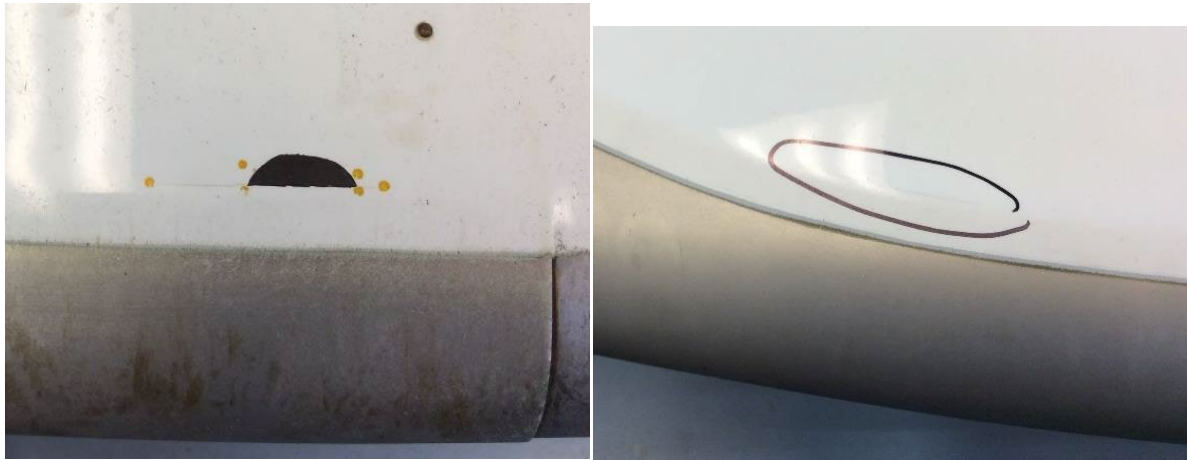
- d. Dents on the leading edge nose or paint cracks along the trailing edge of any abrasion strip are possible evidence of a leading edge impact (see Figure 5-2). Perform the Section 5.9 inspection and refer to skin void criteria in section 5.10.3.

Figure 5-2  
Paint Cracks indicating leading edge impact
