**400W Series**  
**Instructions for Continued Airworthiness**  
**Bell 206L Series**

**Dwg. Number:**  
**190-01226-12 Rev. 3**

**Garmin International, Inc.**  
**1200 E. 151st Street**  
**Olathe, Kansas 66062 USA**

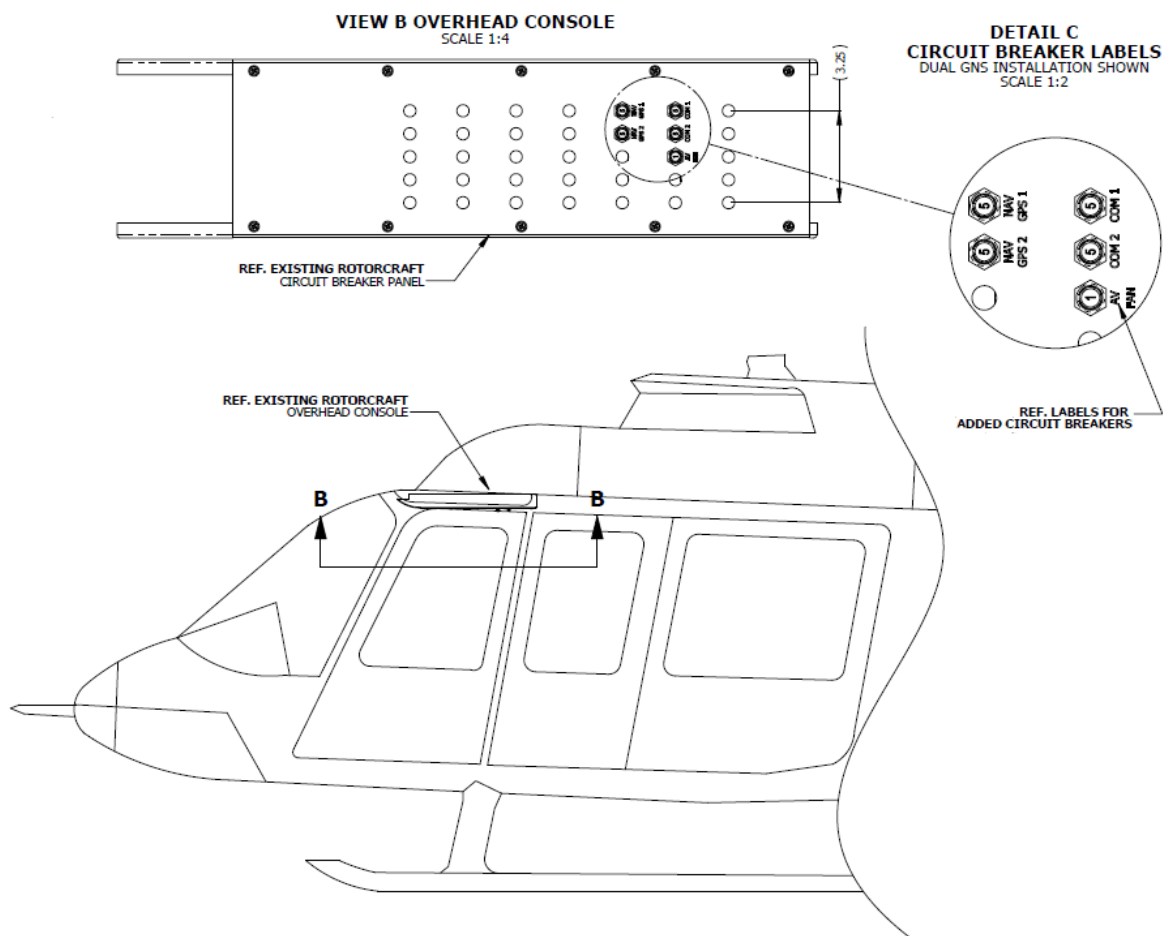
The installed equipment is connected to an avionics bus that receives power as soon as the battery and avionics master switches are turned on. Circuit breakers are installed on an overhead circuit breaker panel as shown below. Note: dual navigator system installation as shown.

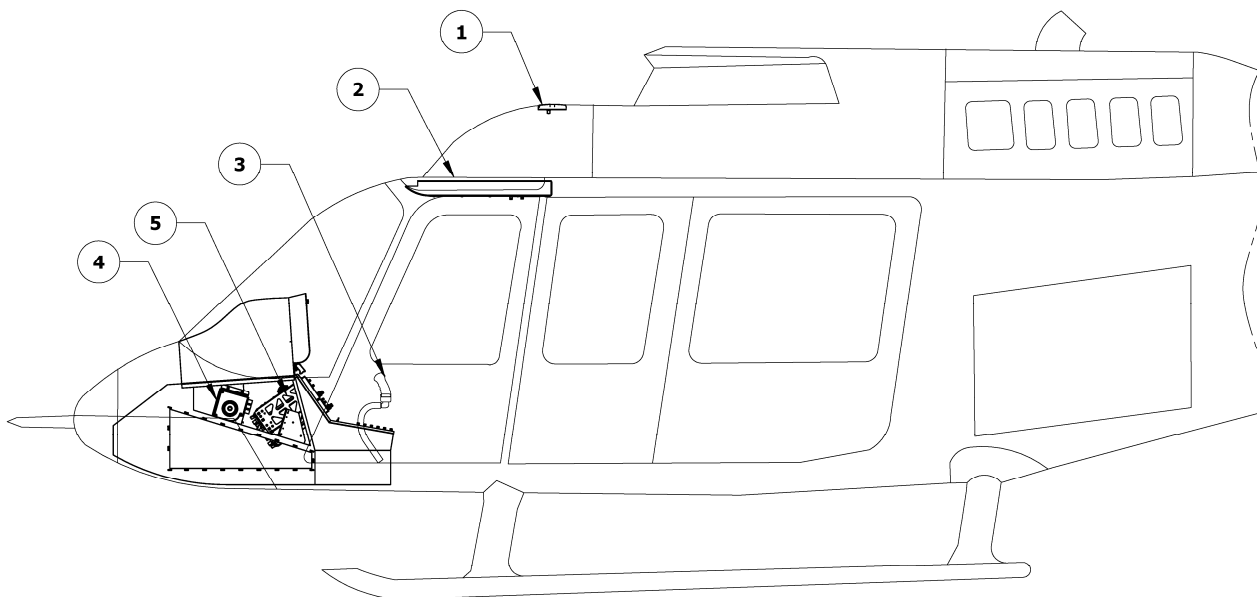
**LRU Access: Bell models 206L Series**

The installed 400W Series equipment can be accessed as described below:

1. GA 35/36/37 ANTENNA: FS82.0 remove by extracting the four mounting screws in the body of the antenna. Note: location may vary slightly depending whether or not a dual navigator system is installed.
2. OVERHEAD CIRCUIT BREAKER PANEL: Access or remove by extracting the mounting screws along the side of the circuit breaker panel.
3. CYCLIC CONTROL GRIPS: remove by extracting mounting screw at bottom of grip.
4. COOLING FAN: FS29.3 Access by removing copilot side (LH) cover plate. Remove by extracting three mounting screws and disconnecting connector.
5. 400W SERIES UNIT: FS40.7 Access or remove by using a 3/32 allen head screwdriver to loosen the locking mechanism through the access hole on the front of the unit. Note: location may vary slightly depending whether or not a dual navigator system is installed.
