**500W Series**  
**Instructions for Continued Airworthiness**  
**Bell 407**

Dwg. Number:  
190-01226-13 Rev. 3

This STC upgrades existing avionics for the Bell 407 rotorcraft as summarized below.

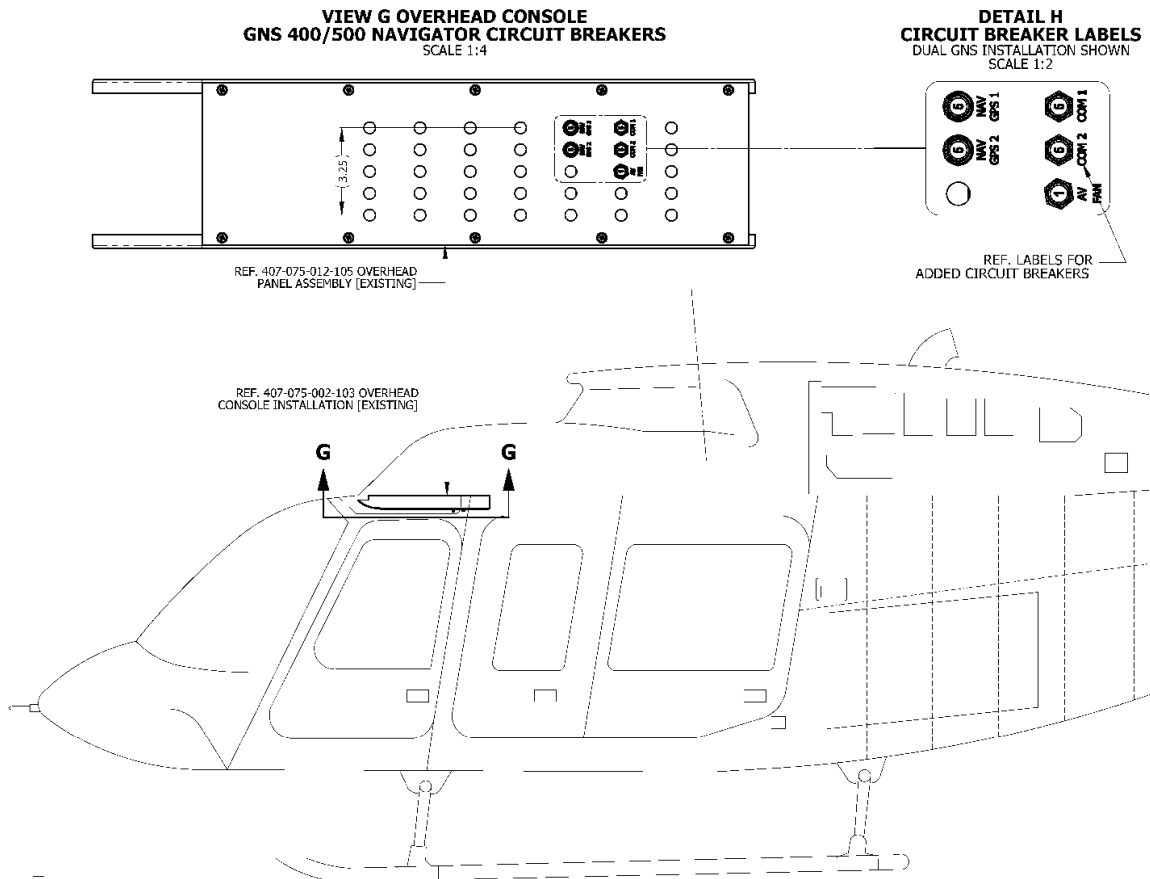
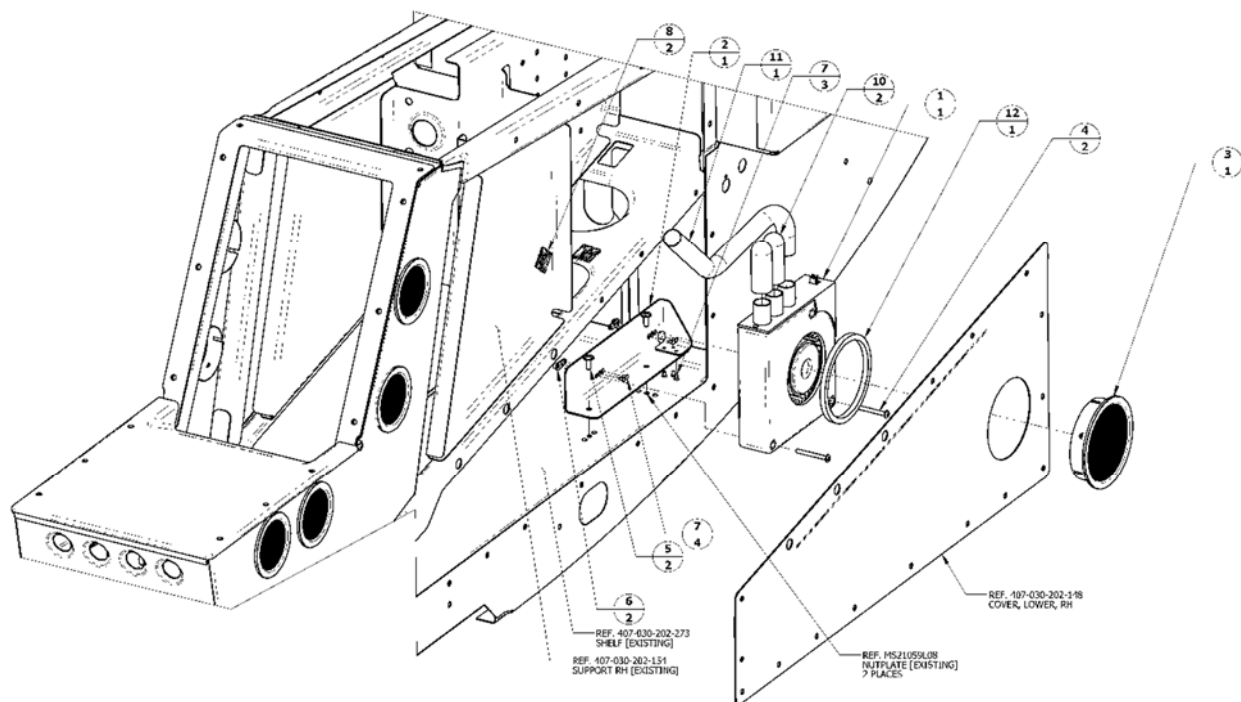
The installed equipment is connected to an avionics bus that receives power as soon as the battery and avionics master switches are turned on. Circuit breakers are installed in the panel located in existing overhead console, as shown below (Note: circuit breakers for dual navigator installation are shown).

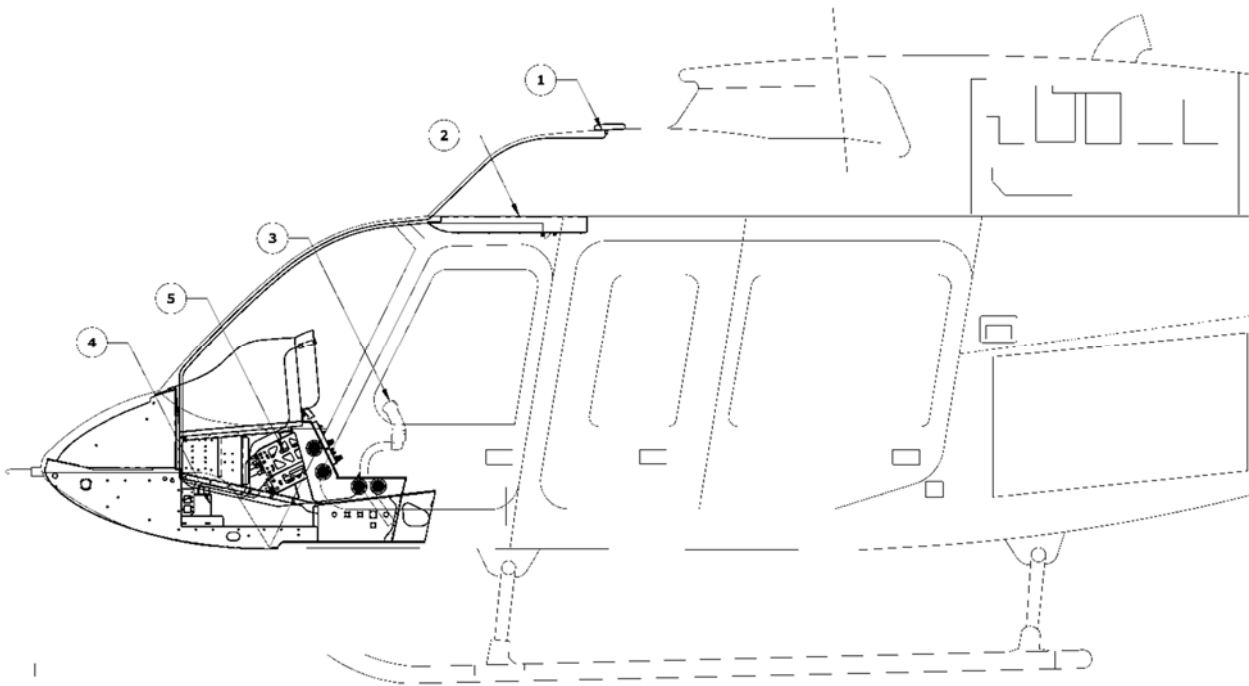
**LRU Access: Bell models 407**

The installed 500W Series equipment can be accessed as described below:

1. GA 35/36/37 ANTENNA: FS84.0 for dual antenna installation; FS79.0 for single antenna installations. Remove environmental seal, remove four antenna screws and lift the antenna enough to disconnect antenna connector.
2. OVERHEAD CIRCUIT BREAKER PANEL: Remove studs securing circuit breaker panel to rotorcraft overhead console to access unit circuit breakers
3. CYCLIC CONTROL GRIPS: remove by extracting mounting screw at bottom of grip.
4. COOLING FAN: FS24.63 Access by removing 407-030-202-148 COVER, LOWER, RH. Remove two screws, disconnect connector and air duct.
5. 500W SERIES UNIT: FS39.5 Access or remove by using a 3/32 allen head screwdriver to loosen the locking mechanism through the access hole on the front of the unit. Note: location may vary slightly depending whether or not a dual navigator system is installed.
