# SERVICE No. 1041 BULLETIN

**Distribution of Airborne Service Letter Number 56,  
"Inspection and Cleaning of Airborne Air Filter Elements"**

**Service Letter Number:** 56

**Subject:** Inspection and Cleaning of Airborne Air Filter Elements.

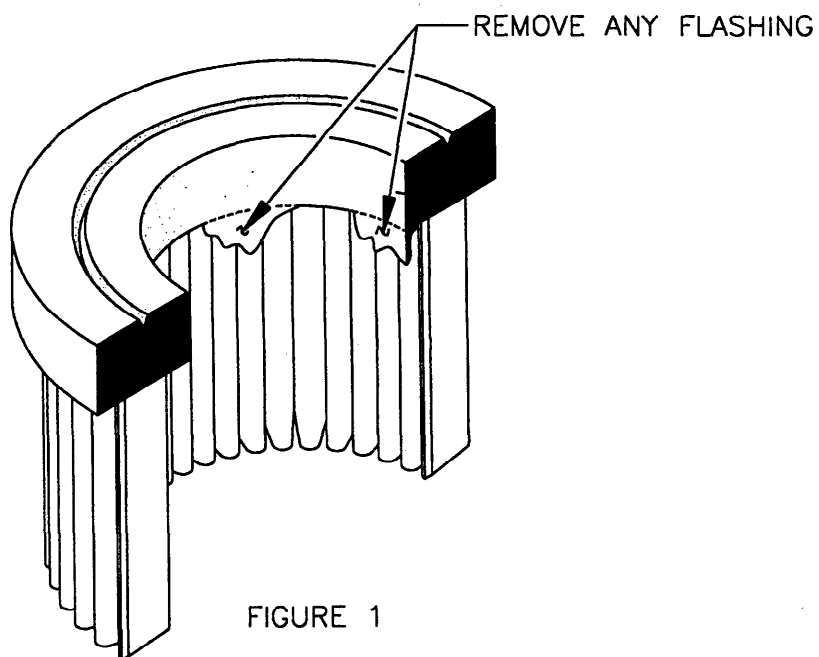
- 1) Remove the affected air filter element from aircraft per the instructions outlined in the appropriate maintenance/service manual provided by the airframe manufacturer.
- 2) Inspect the inner diameter of the black end piece(s) of these elements for flashing (Figure 1). Remove all flashing using a sharp knife. Caution: Do not cut the paper filter portion of the element.

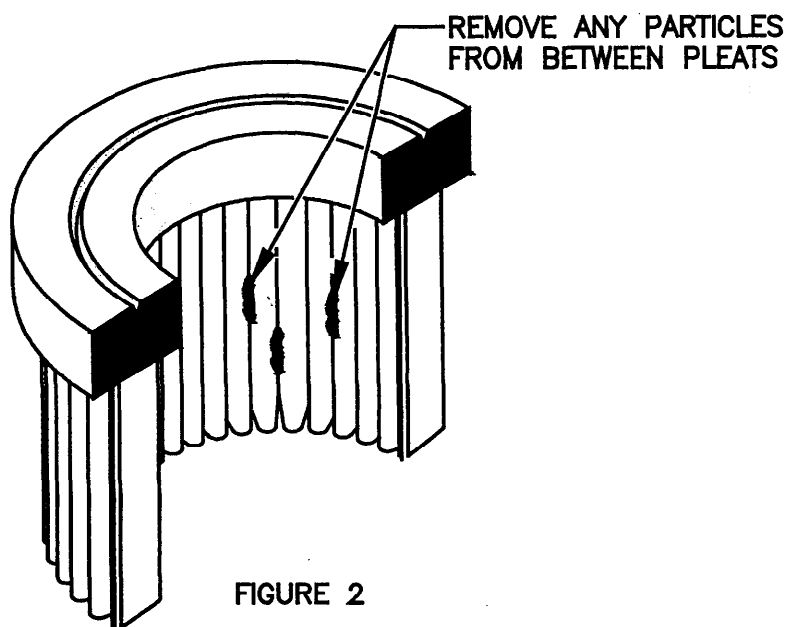
- 3) Tap the element lightly on a clean work surface in order to remove any loose particles from between the pleat tips on the inside of the paper filter (Figure 2).

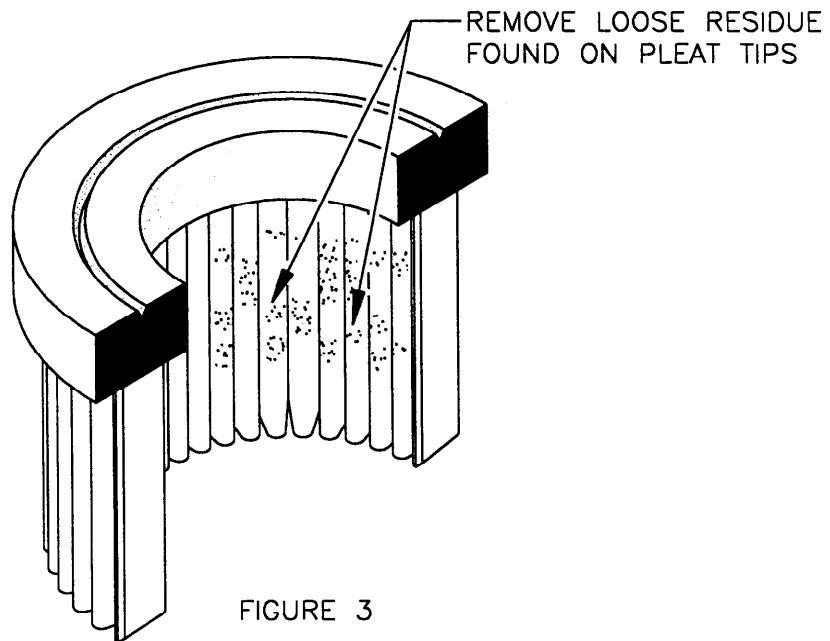
- 4) Inspect the inner diameter (pleat tips) of the paper filter for black residue (Figure 3). Remove all loose residue using the "sticky side" of a strip of masking tape attached to the end of a blunt instrument.

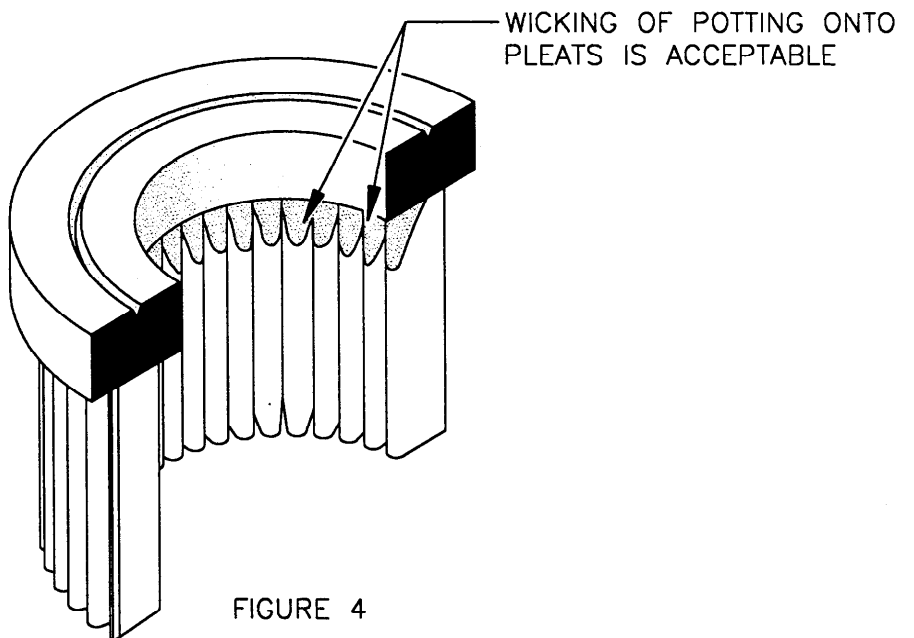
- 6) Thoroughly inspect all internal surfaces of the element for any loose particles. Remove any remaining loose particles using any combination of the above steps. Note: The wicking of black potting material onto pleats of paper filter is acceptable (Figure 4).
