## REVISION TRANSMITTAL

FLIGHT CONTROLS - ELEVATOR TRIM-TAB PUSH-PULL TUBE HARDWARE REPLACEMENT

MEB-27-02  
Page 1 of 8

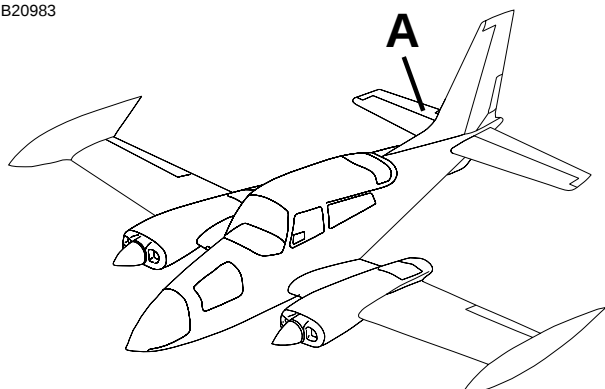
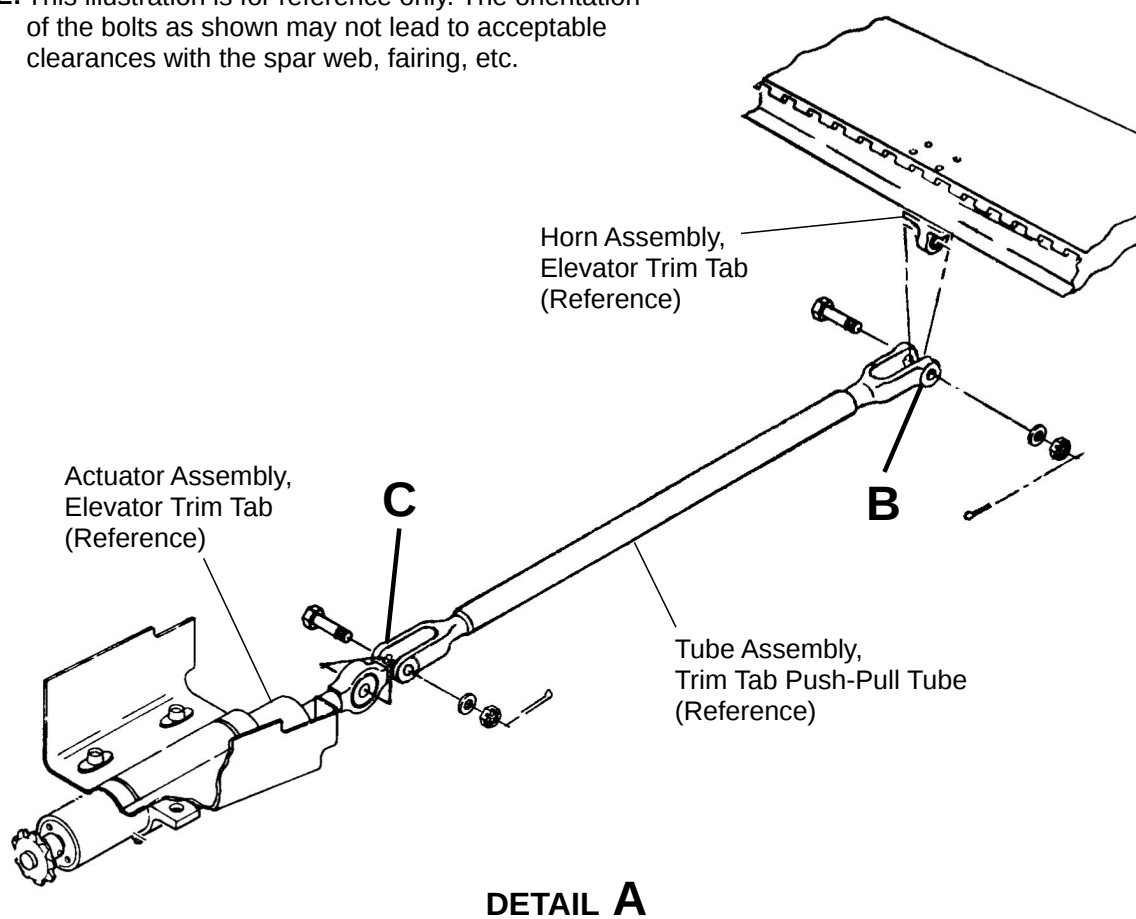
Figure 1. Elevator Trim-Tab Push-Pull Tube Hardware (Sheet 1)

**NOTE:** Model 310R shown, location for trim tab push-pull tube similar on other models.

**NOTE:** This illustration is for reference only. The orientation of the bolts as shown may not lead to acceptable clearances with the spar web, fairing, etc.

4. (Refer to Figure 1, Sheet 1 and Sheet 2.) Install the NAS464P3-8 Bolt, NAS1149F0332P Washer, MS17826-3 Nut and MS24665-132 Cotter Pin in the elevator trim tab actuator rod end to push-pull tube connection as follows:

**NOTE:** It is permissible to substitute the NAS464P3-X bolt with a NAS6203-X bolt.  
  - A. (Refer to Figure 1, Sheet 1 and Sheet 2.) Install the NAS464P3-8 Bolt in the elevator trim tab actuator rod end to push-pull tube connection in the orientation (i.e., bolt head inboard or outboard) which yields the greatest clearance with the spar web cut-out and any other structures.

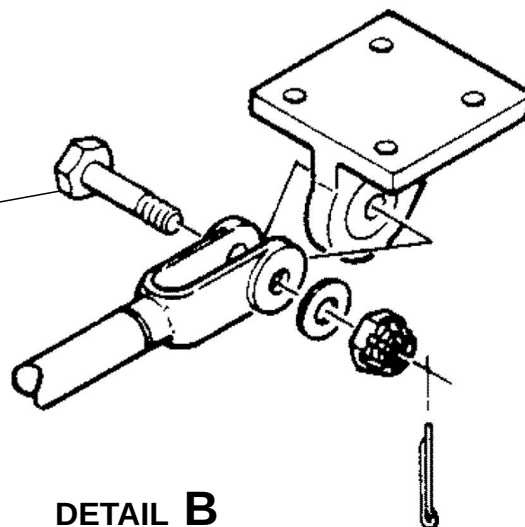
**DETAIL B**

NAS464P3-8 or  
NAS464P3-9  
Bolt  
(1 Required)  
NAS1149F0332P  
and/or  
NAS1149F0316P  
Washer  
(1 or More as Required)  
MS17826-3  
Nut  
MS24665-132  
Cotter Pin  
(1 Each Required)

**NOTE:** This illustration is for reference only.  
The orientation of the bolts as shown may  
not lead to acceptable clearances with  
the spar web, fairing, etc.

**NOTE:** It is permissible to substitute the NAS464P3-X bolt with a NAS6203-X bolt.
  - B. Install the NAS1149F0332P Washer and MS17826-3 Nut onto the NAS464P3-8 Bolt.
  - C. Torque the MS17826-3 Nut 12 Inch-Pounds, if a castellation of the nut does not align with the cotter pin hole in the bolt, continue tightening to the next alignment position up to 20 Inch-Pounds.
  - D. Make sure a minimum of one full bolt thread is protruding from the castellated nut.
  - E. Install the MS24665-132 Cotter Pin.
5. (Refer to Figure 1, Sheet 1 and Sheet 2.) Remove the nut, washer and bolt from the elevator trim actuator push-pull tube to elevator trim tab horn.  
  - A. Discard the removed hardware.

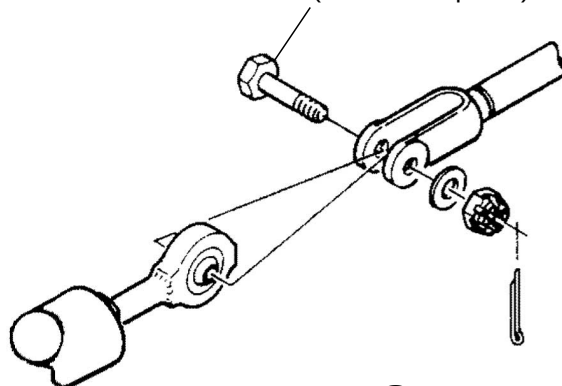
**DETAIL C**

NAS464P3-8 or  
NAS464P3-9  
Bolt  
(1 Required)  
NAS1149F0332P  
and/or  
NAS1149F0316P  
Washer  
(1 or More as Required)  
MS17826-3  
Nut  
MS24665-132  
Cotter Pin  
(1 Each Required)

**NOTE:** Any fit problems may be correctable by cleaning out the debris in the internal hole surface of the bearing and/or the clevis or by replacement of the rod or bearing if corrosion or damage dictates the parts cannot be used as is.
6. (Refer to Figure 1, Sheet 1 and Sheet 2.) Install the NAS464P3-8 Bolt, NAS1149F0332P Washer, MS17826-3 Nut and MS24665-132 Cotter Pin in the elevator trim tab actuator push-pull tube to elevator trim tab horn connection as follows:

**NOTE:** It is permissible to substitute the NAS464P3-X bolt with a NAS6203-X bolt.  
  - A. (Refer to Figure 1, Sheet 1 and Sheet 2.) Install the NAS464P3-8 Bolt in the push-pull tube to elevator trim tab horn.

**NOTE:** It is permissible to substitute the NAS464P3-X bolt with a NAS6203-X bolt.
  - B. Install the NAS1149F0332P Washer and MS17826-3 Nut onto the NAS464P3-8 Bolt.
  - C. Torque the MS17826-3 Nut 12 Inch-Pounds, if a castellation of the nut does not align with the cotter pin hole in the bolt, continue tightening to the next alignment position up to 20 Inch-Pounds.
  - D. Make sure a minimum of one full bolt thread is protruding from the castellated nut.
  - E. Install the MS24665-132 Cotter Pin.
7. Check the elevator and elevator trim system for uninterrupted, proper operation through the full travel of the elevator and elevator trim tab surfaces (pitch up/pitch down and nose up/nose down respectively).
